Subject: Oakland Zoo “California Trail” project construction – Violations of environmental protections for rare native grassland and Alameda Striped Racer habitat

Part B: Specific Environmental Protections in Perimeter Fence Building Permit #PZ1500051 and Actual EBZS Compliance

Attachments with photo documentation and reference to map location

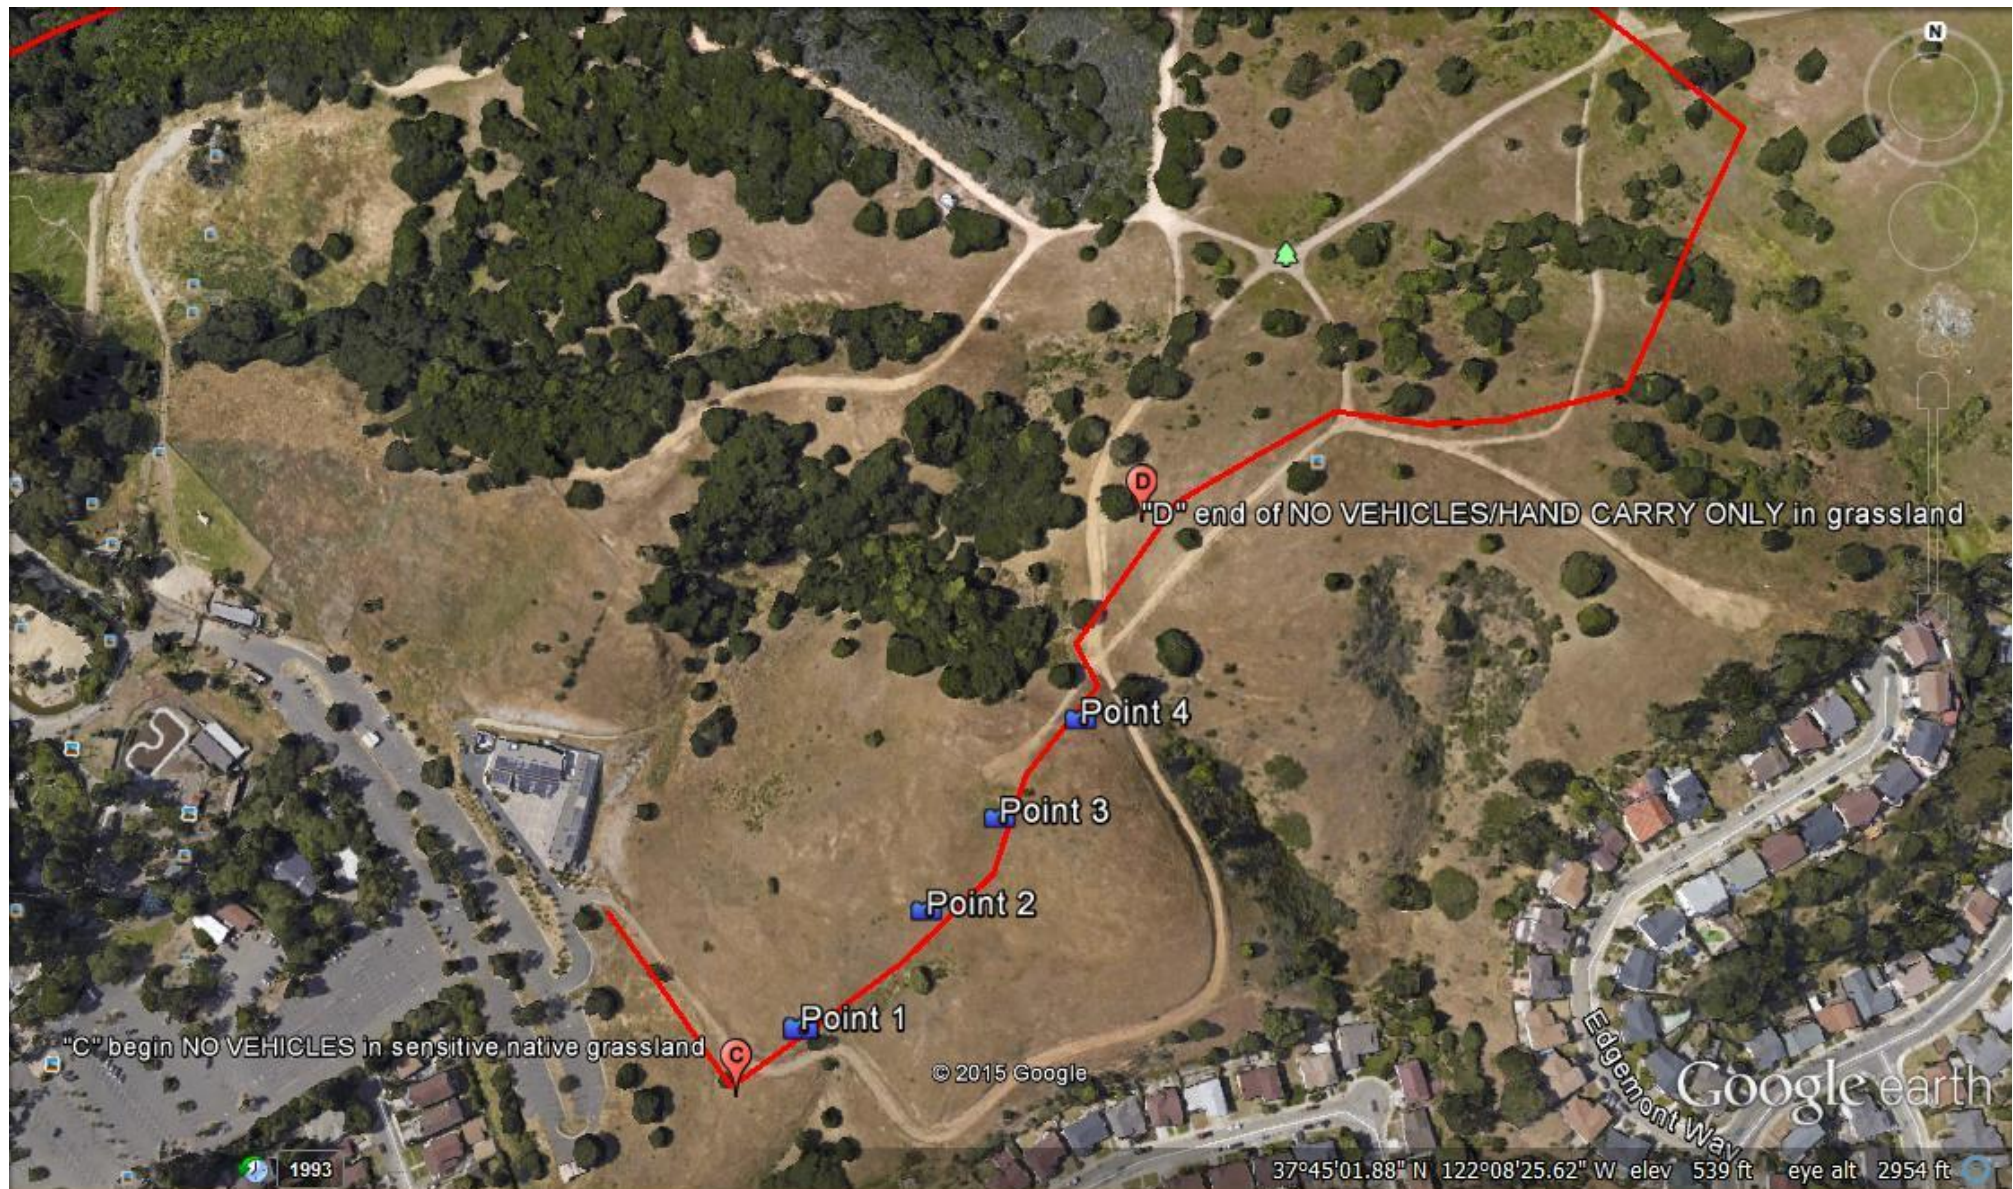
Satellite image with the locations of the four reference points that were observed via a handheld GPS device as follows:

Point 1 - N37.74887, W122.14132; Point 2 - N37.74923, W122.14072

Point 3 - N37.74953, W122.14046; Point 4 - N37.75020, W122.14005

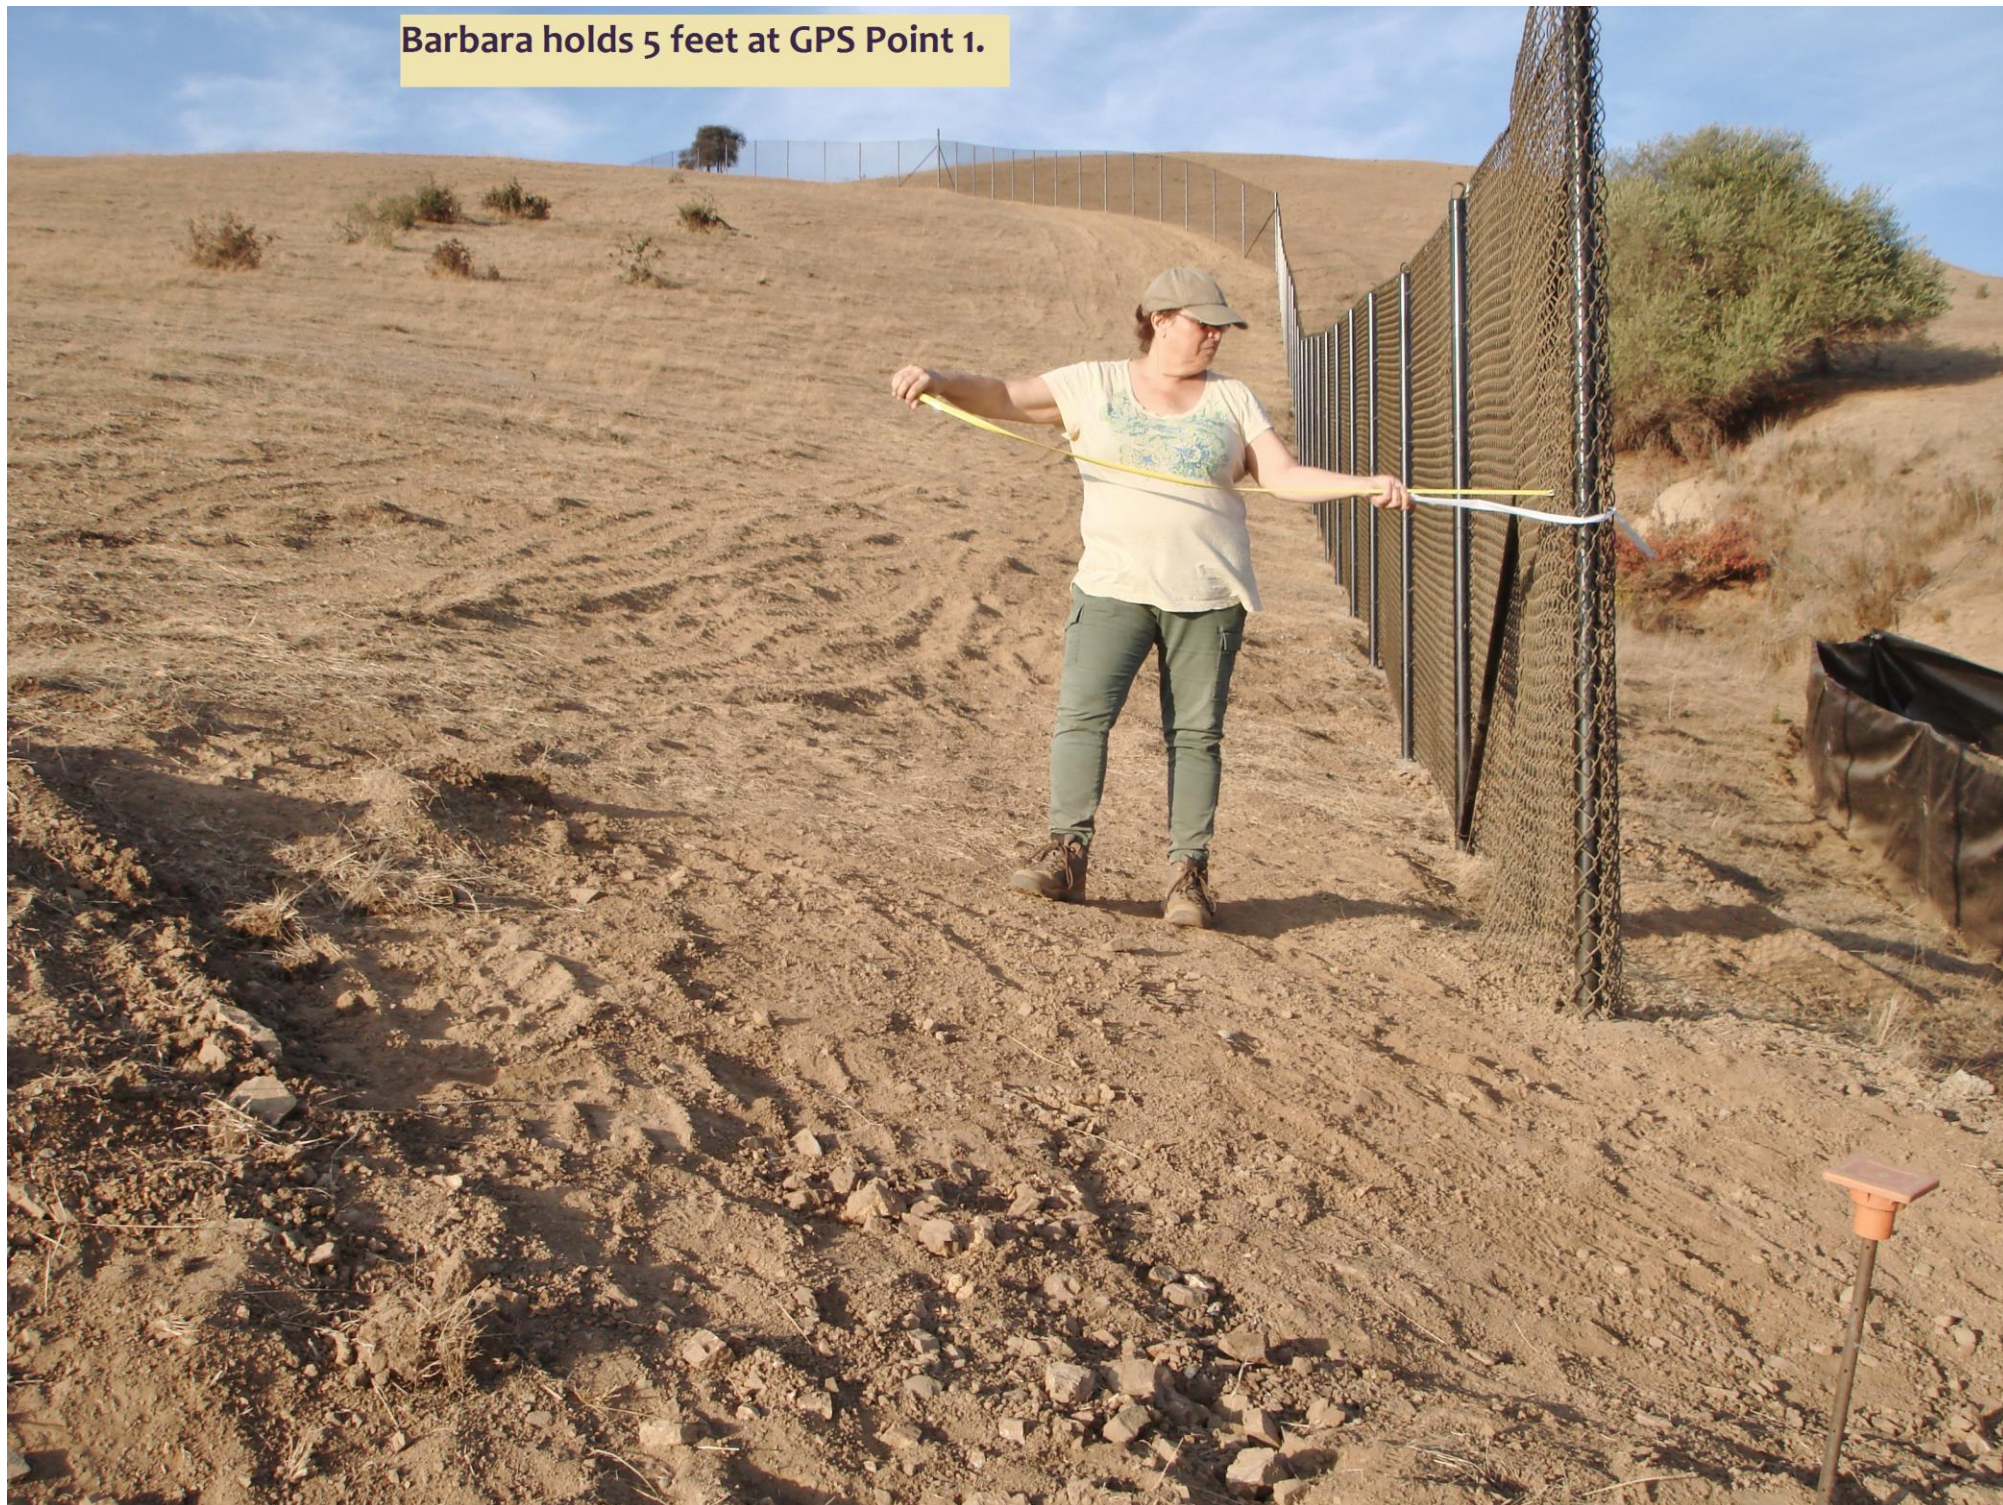
Barbara holds 5 feet at GPS Point 1.

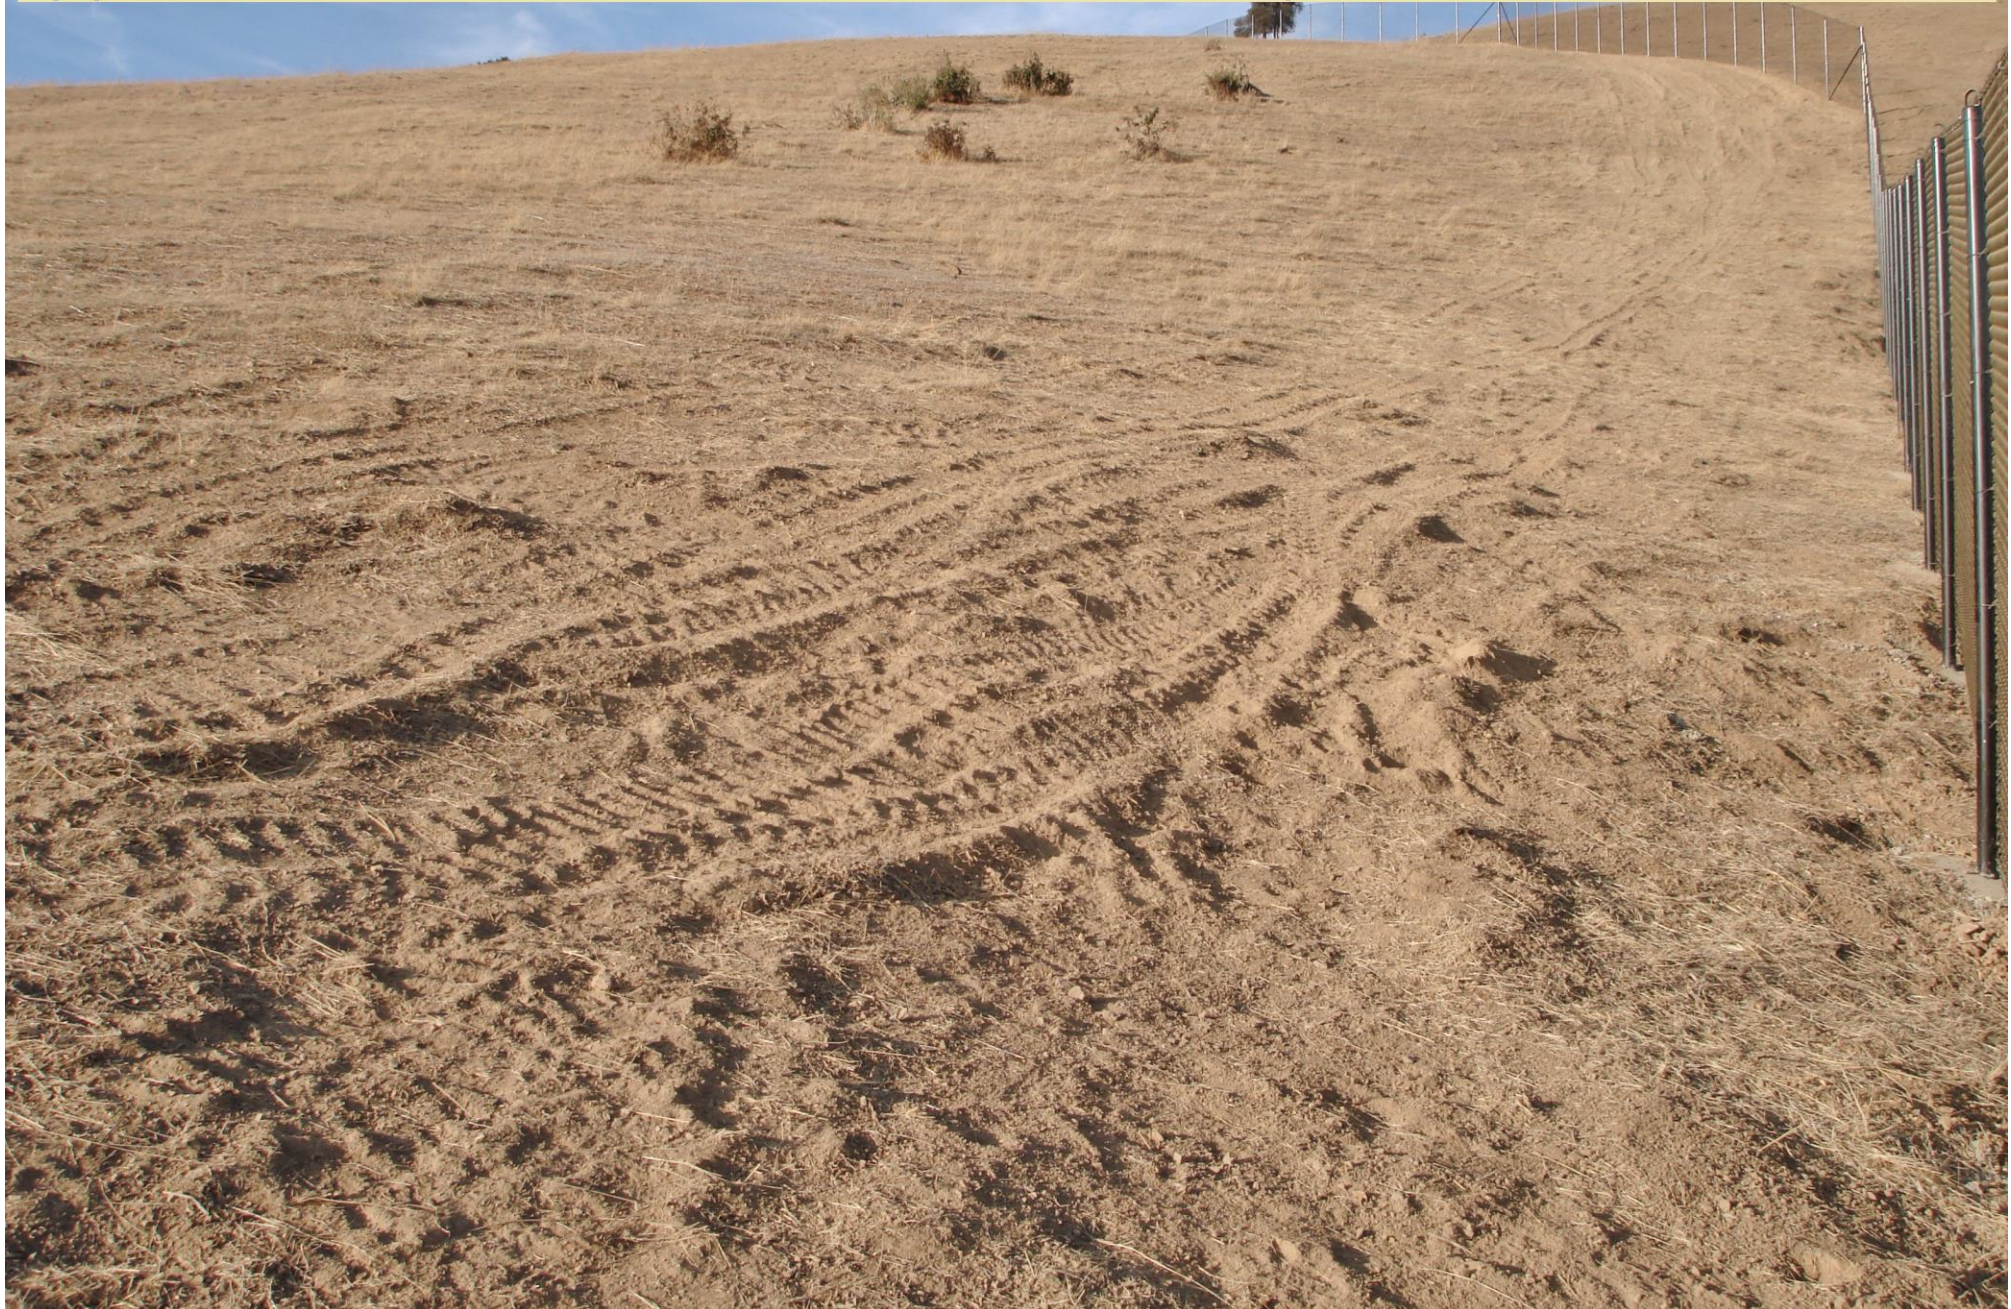
Looking up the hill from GPS Point 1 at the GREATLY disturbed fragile native grassland soil. We estimated the width of this disturbance as conservatively 20 feet on this side of the fence. Added to 10 feet of disturbance on the other side, this equals a 30 foot wide swath of fragile native grassland soil disturbed by tire tracks from mechanized equipment. In this area of the fence installation, tools and materials were specified to be hand carried...

We believe this serious level of site damage requires that the City and appropriate environmental regulatory **agencies issue a stop-work order on the perimeter fence immediately** (building permit #PZ1500051) until the environmental damage is corrected and independent inspection and oversight are established and funded through enforcement action, as described below:

1. Develop and publish a restoration plan, performance criteria, and a timeline to restore the rare native grassland prairie system by reestablishing native grassland species cover and species richness to the background levels of this west-facing hill (i.e., include reestablishment of *Stipa pulchra*, *Calochortus luteus*, *Eriogonum nudum*, *Chlorogalum pomeridianum*, *Sidalcea malviflora ssp. malviflora*, *Festuca octoflora*, *Navarretia mellita*, *Viola pedunculata*, *Koeleria macrantha* and all other species found on this hillside (refer to Knowland Park botanical inventory by Diane Lake, California Native Plant Society, 1/2011). Plants are to be grown and established from seed collected on site. Invasive non-native weeds that are introduced or expanded due to the disturbed soil conditions are to be completely eradicated.

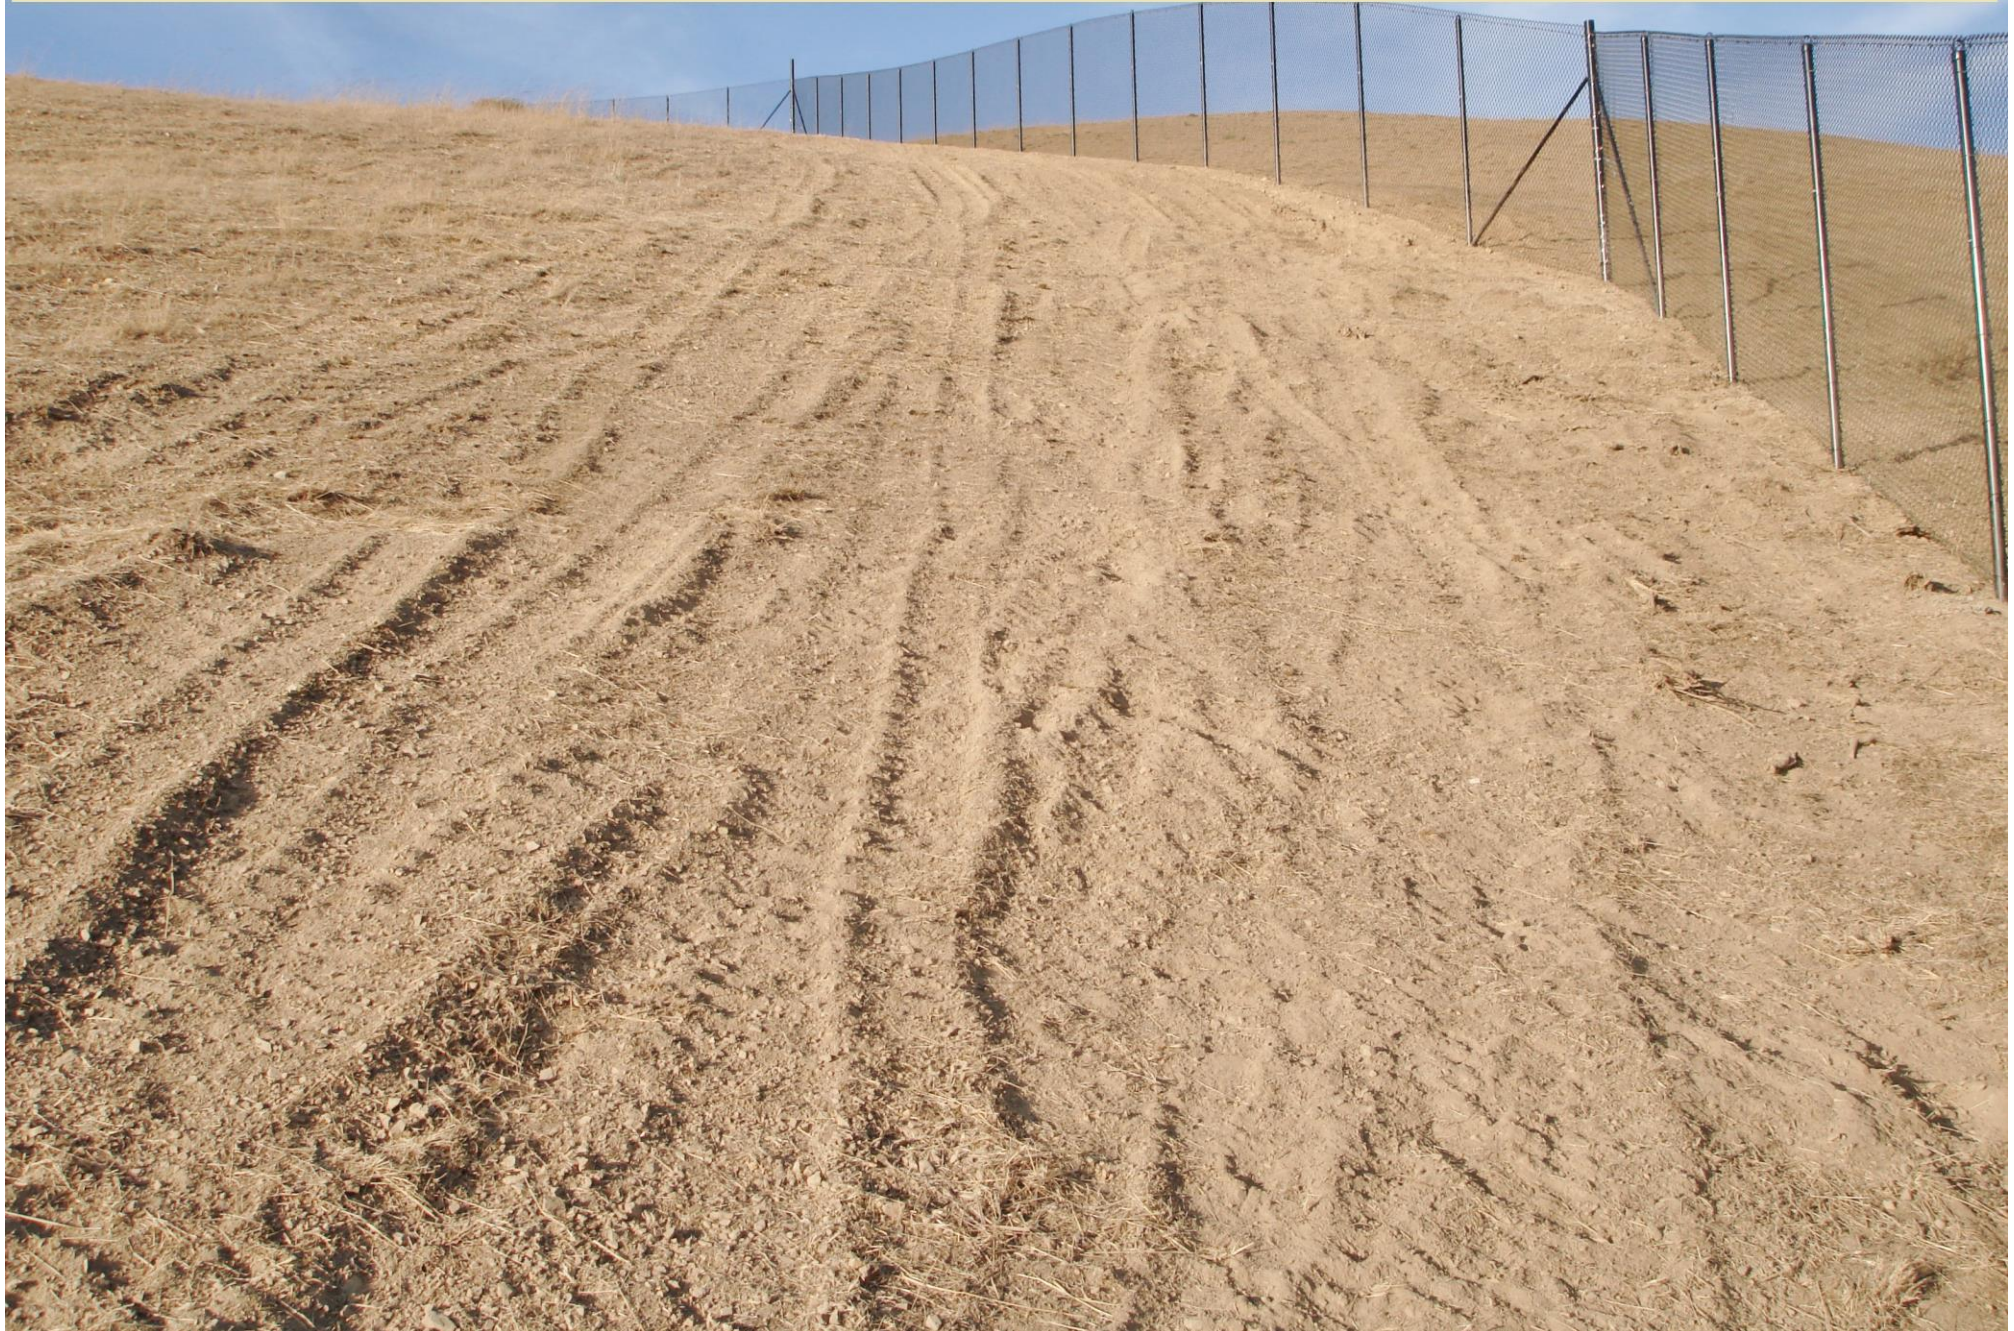
Looking up the hill at the two angle-points in the fence with large diameter posts at GPS Point 3 and GPS Point 2. We counted 14 fence posts between GPS Point 3 and GPS Point 2, yielding a distance along the ground of about 140 feet of disturbed soil with a conservatively estimated swath 30 feet wide.

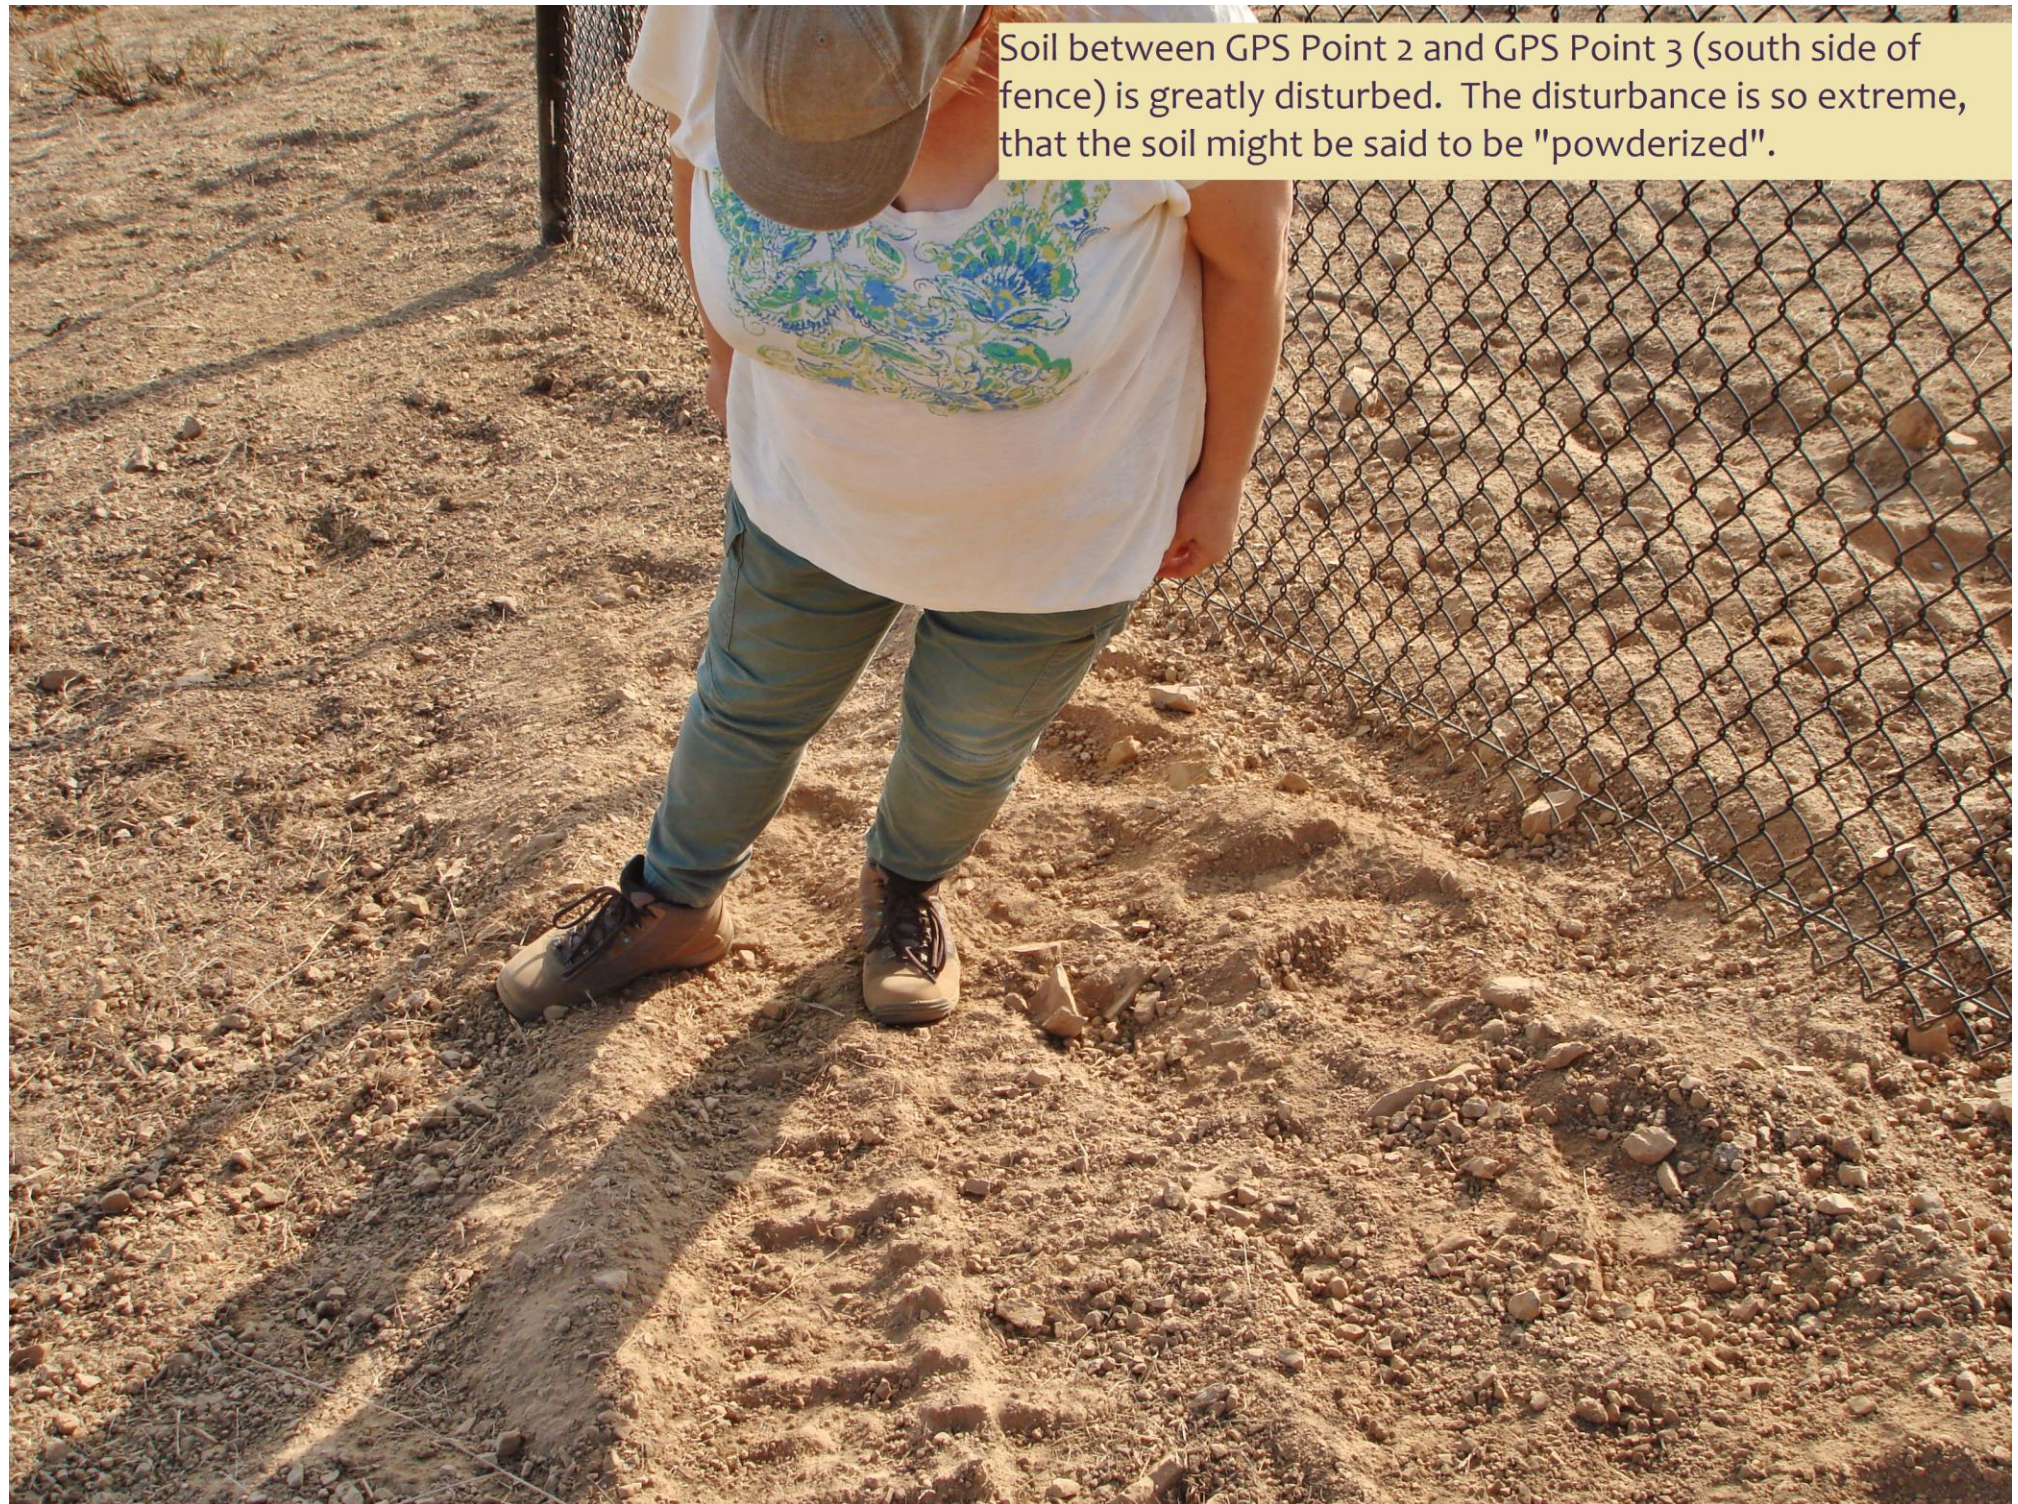
Soil between GPS Point 2 and GPS Point 3 (south side of fence) is greatly disturbed. The disturbance is so extreme, that the soil might be said to be "powderized".

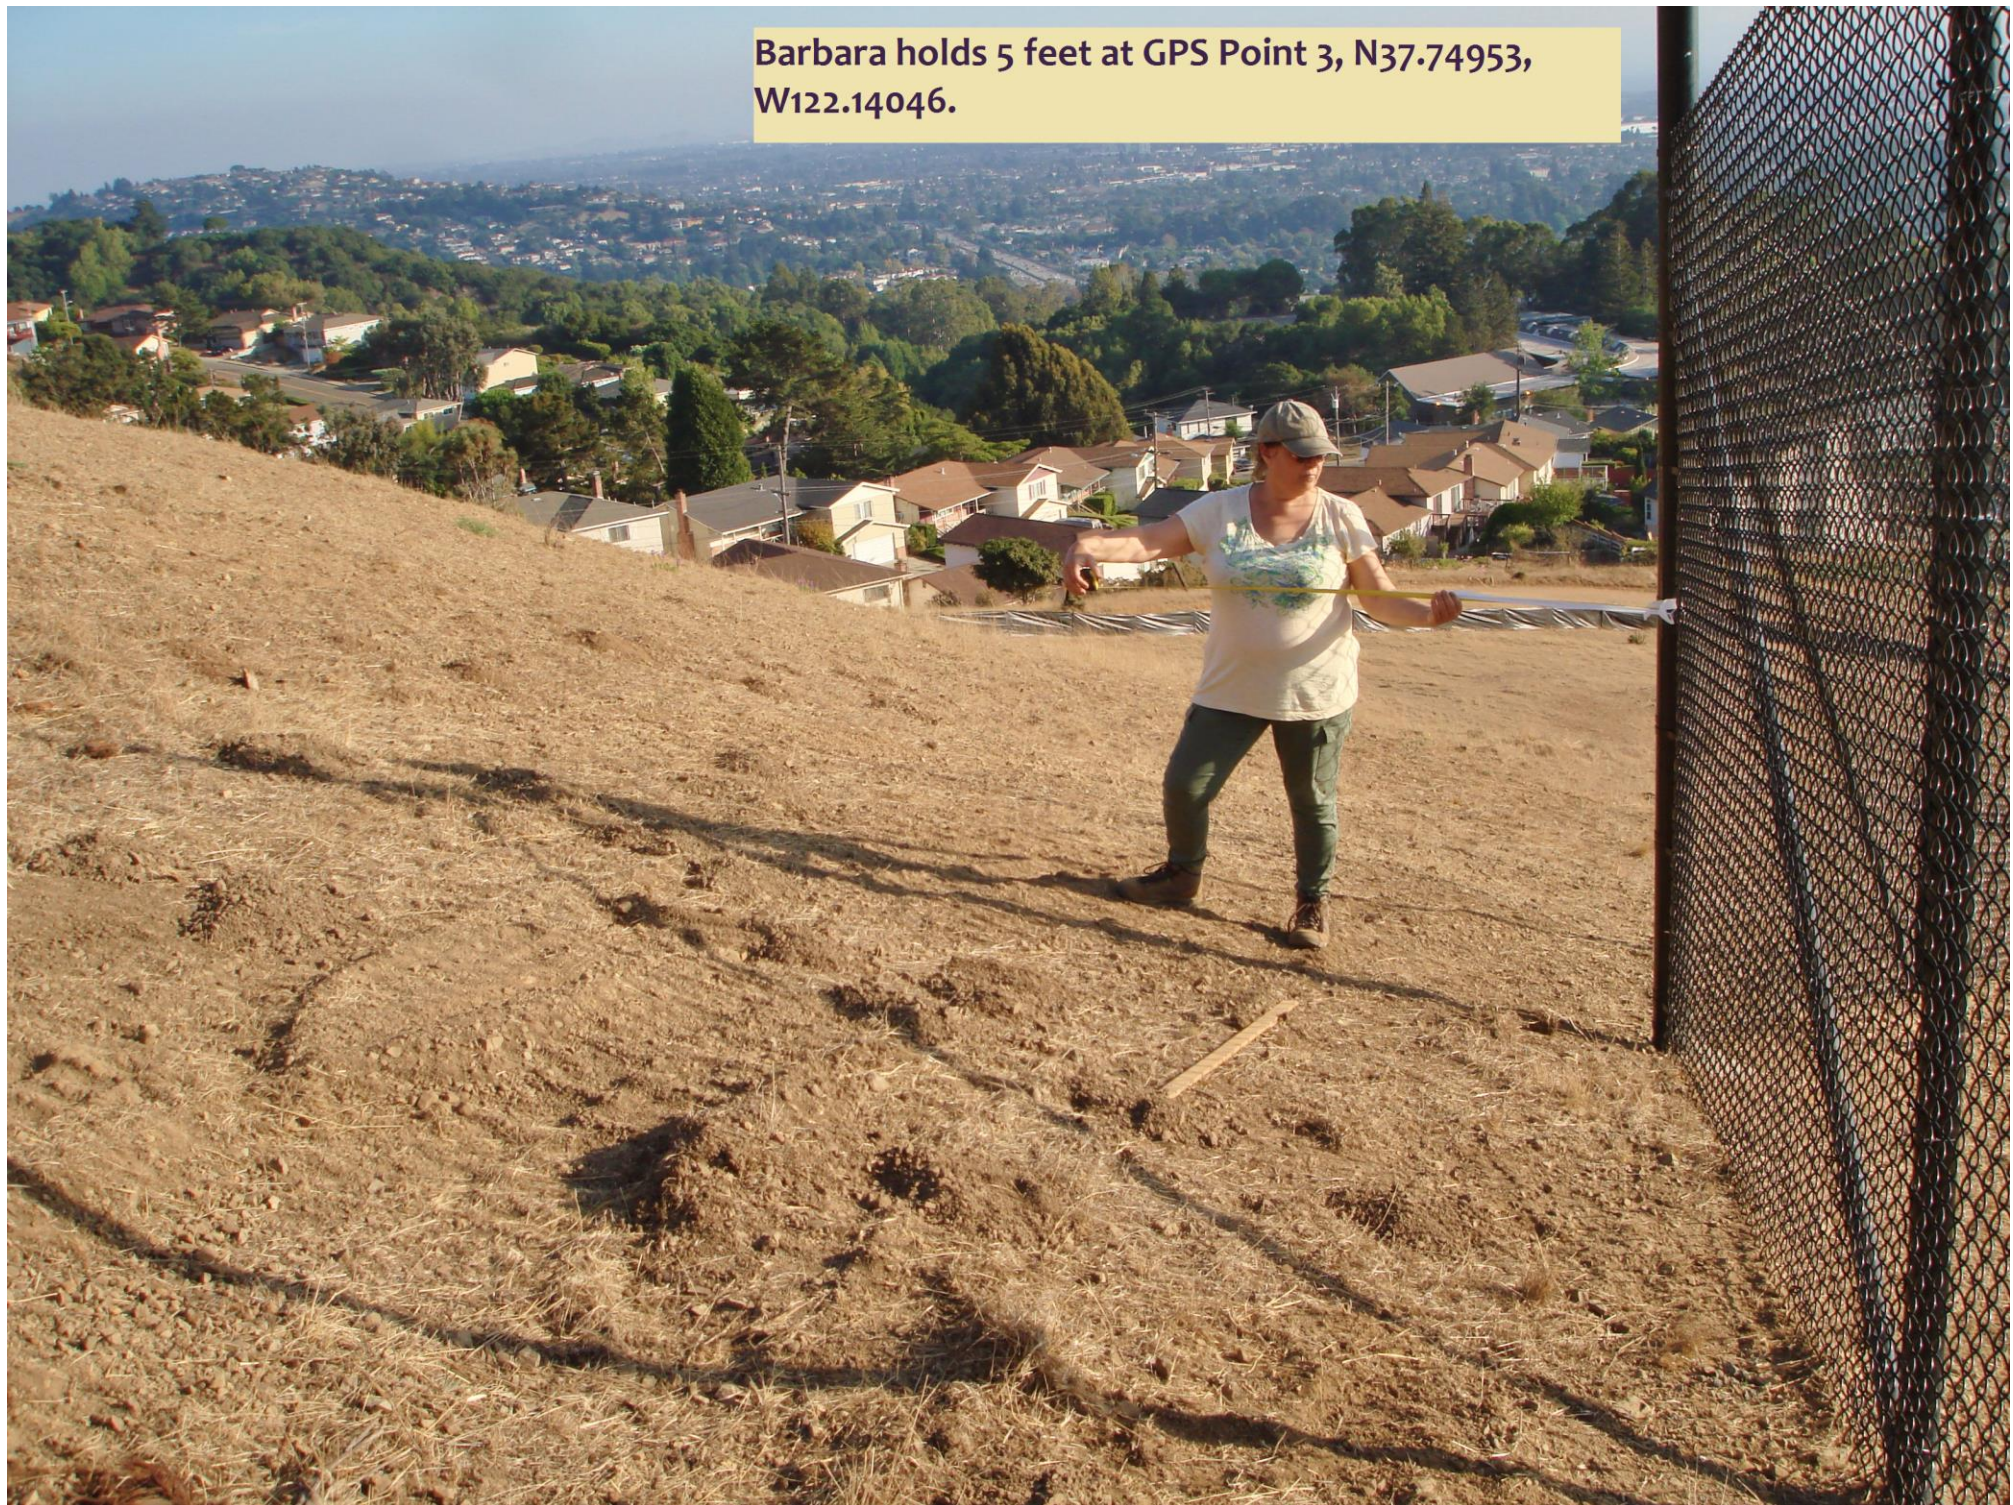
Barbara holds 5 feet at GPS Point 3, N37.74953,
W122.14046.

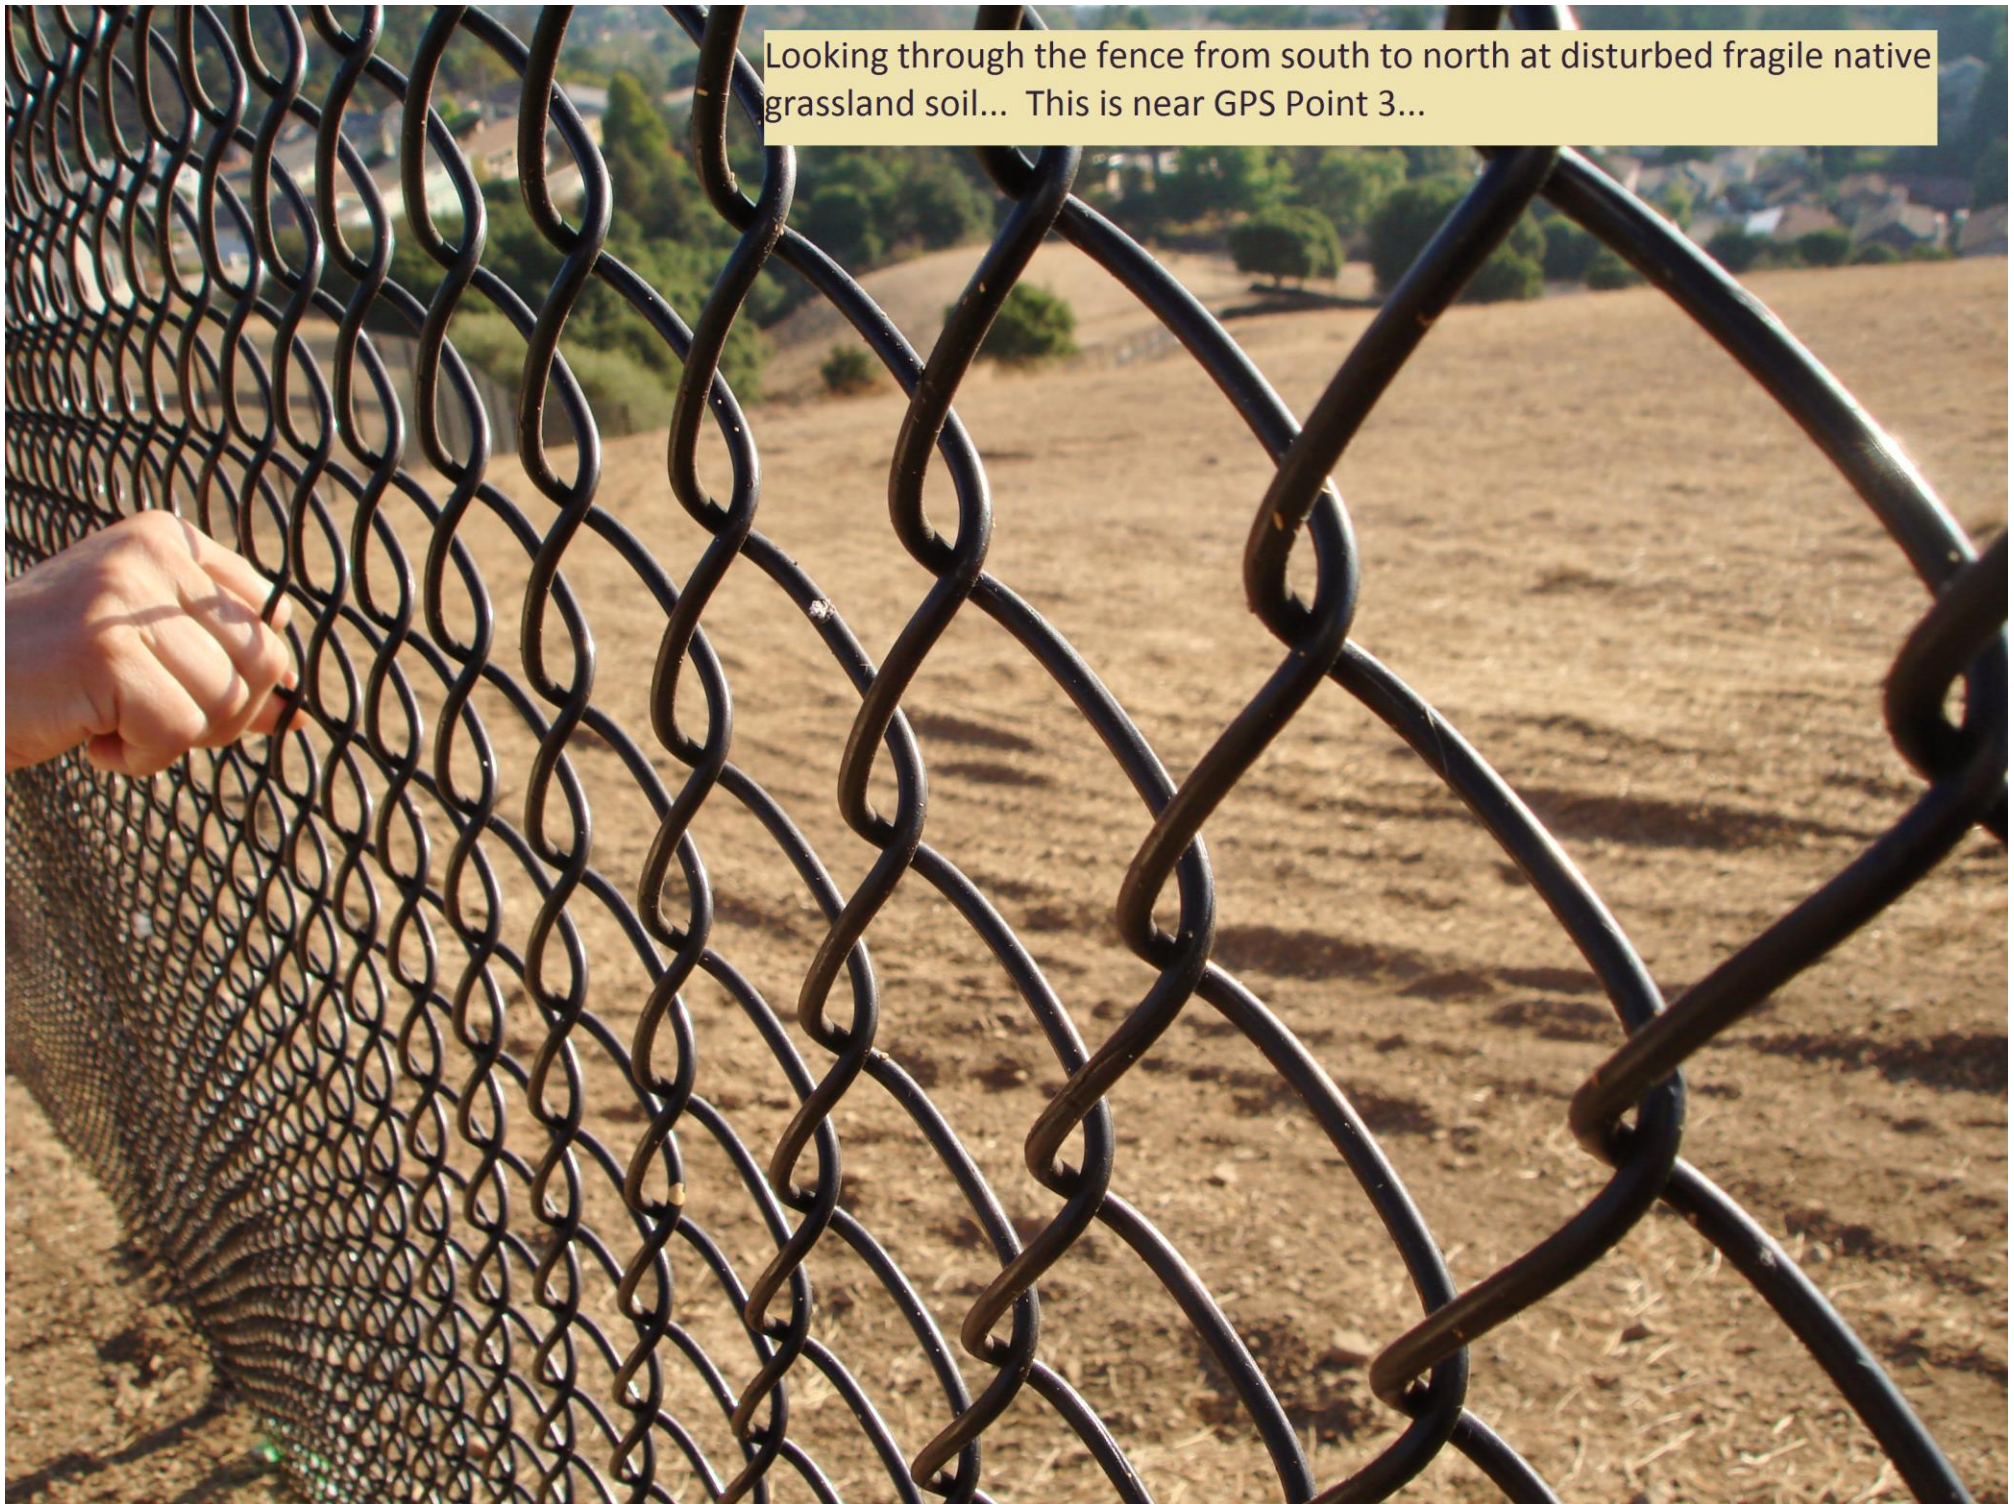
Looking through the fence from south to north at disturbed fragile native grassland soil... This is near GPS Point 3...
