Subject: Oakland Zoo “California Trail” project construction – Violations of environmental protections for rare native grassland and Alameda Striped Racer habitat

Part B: Specific Environmental Protections in Perimeter Fence Building Permit #PZ1500051 and Actual EBZS Compliance

Attachments with photo documentation and reference to map location

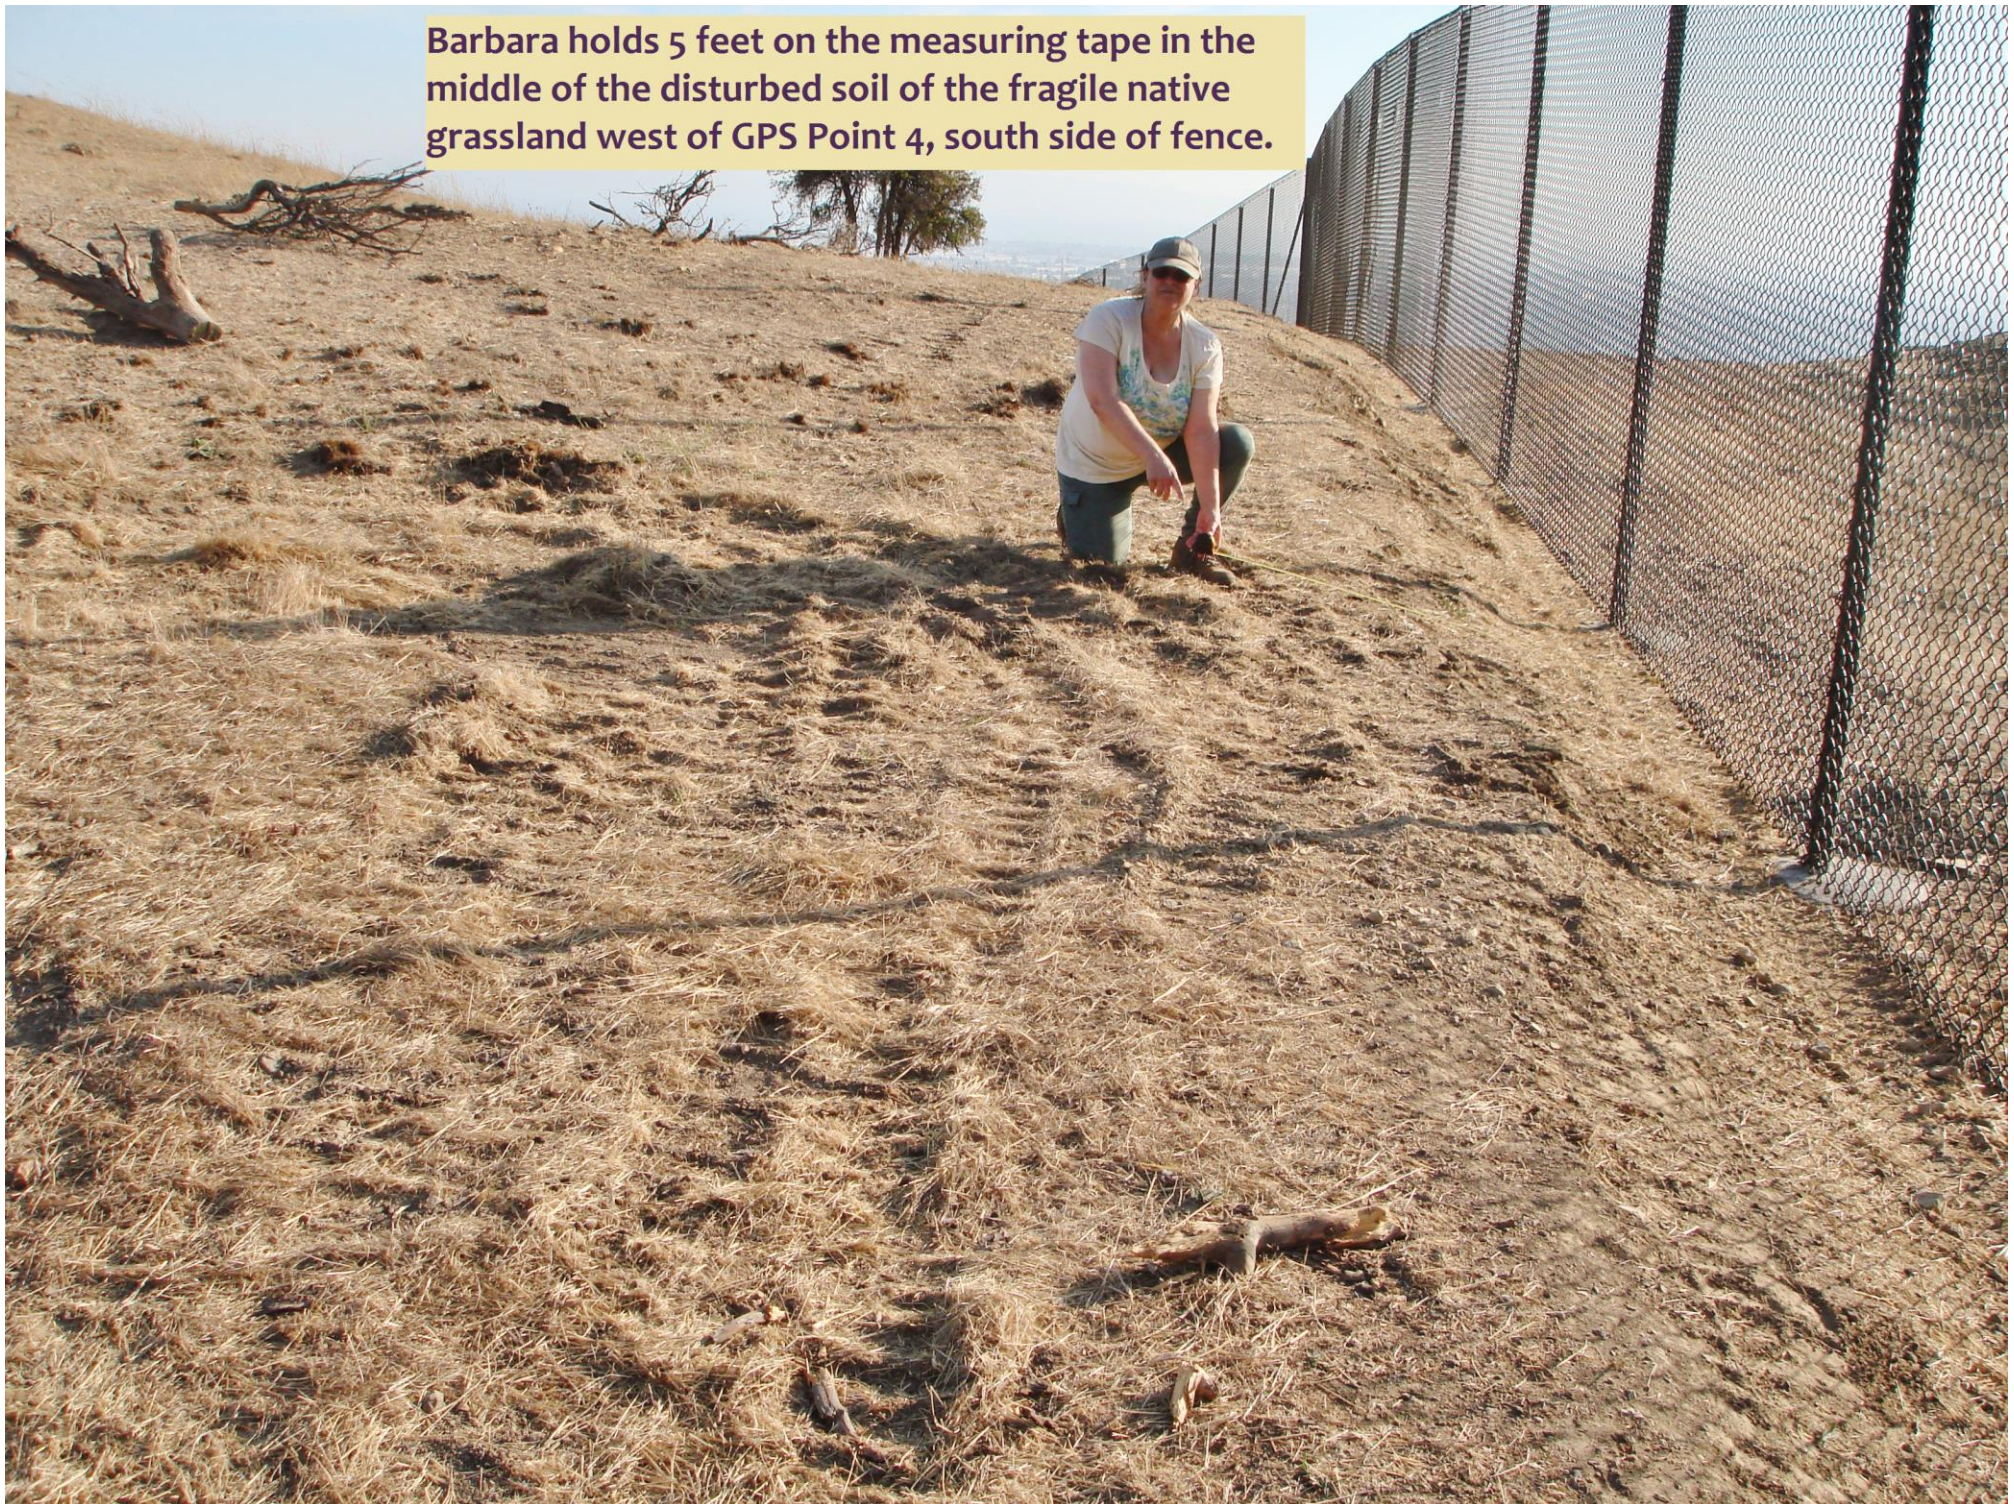
Barbara holds 5 feet on the measuring tape in the middle of the disturbed soil of the fragile native grassland west of GPS Point 4, south side of fence.

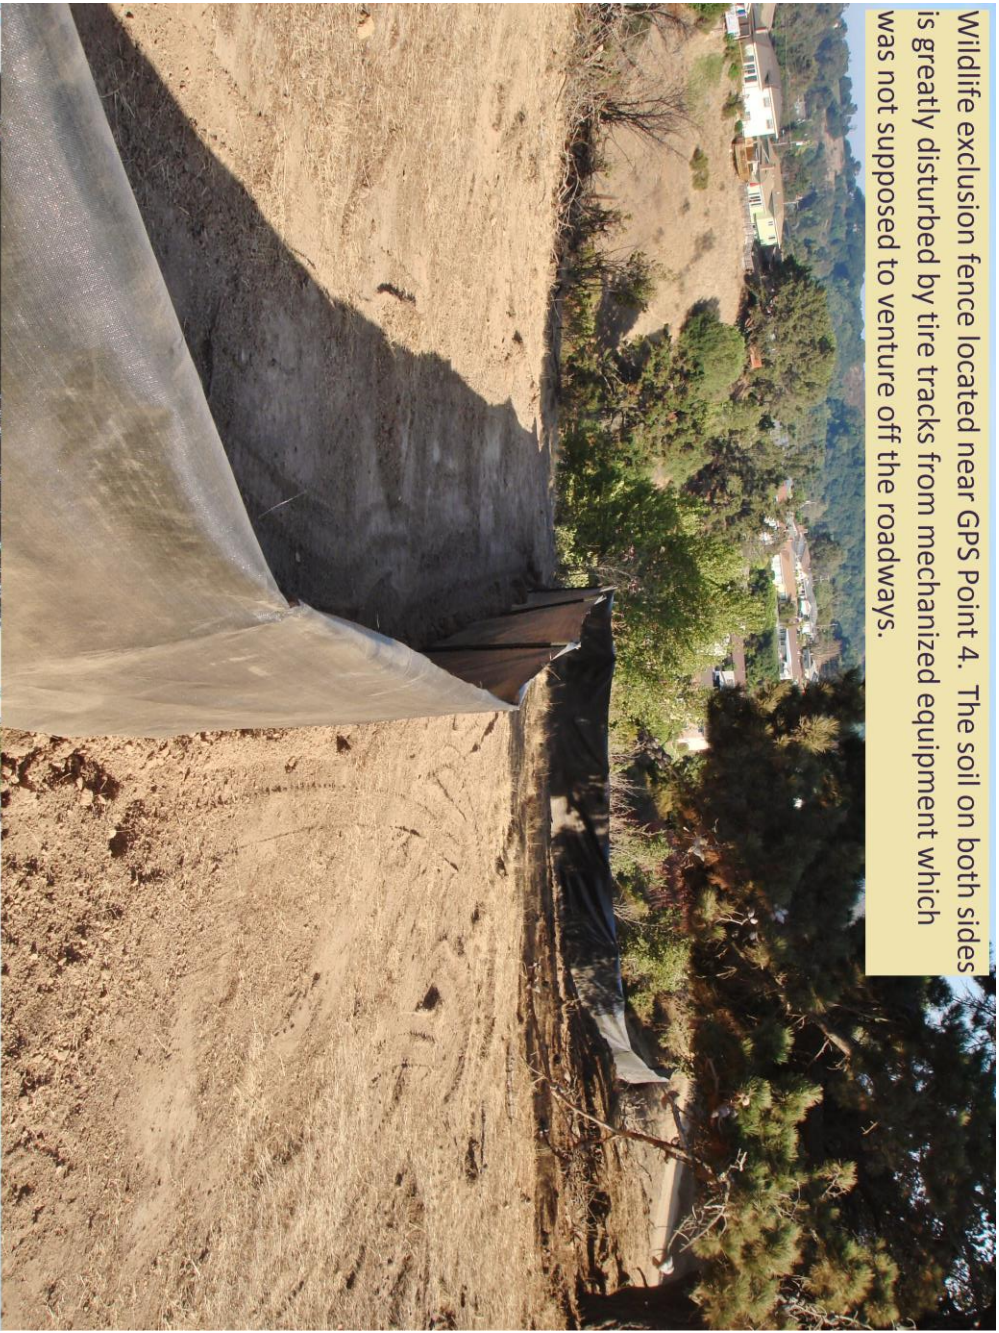
Wildlife exclusion fence located near GPS Point 4. The soil on both sides is greatly disturbed by tire tracks from mechanized equipment which was not supposed to venture off the roadways.

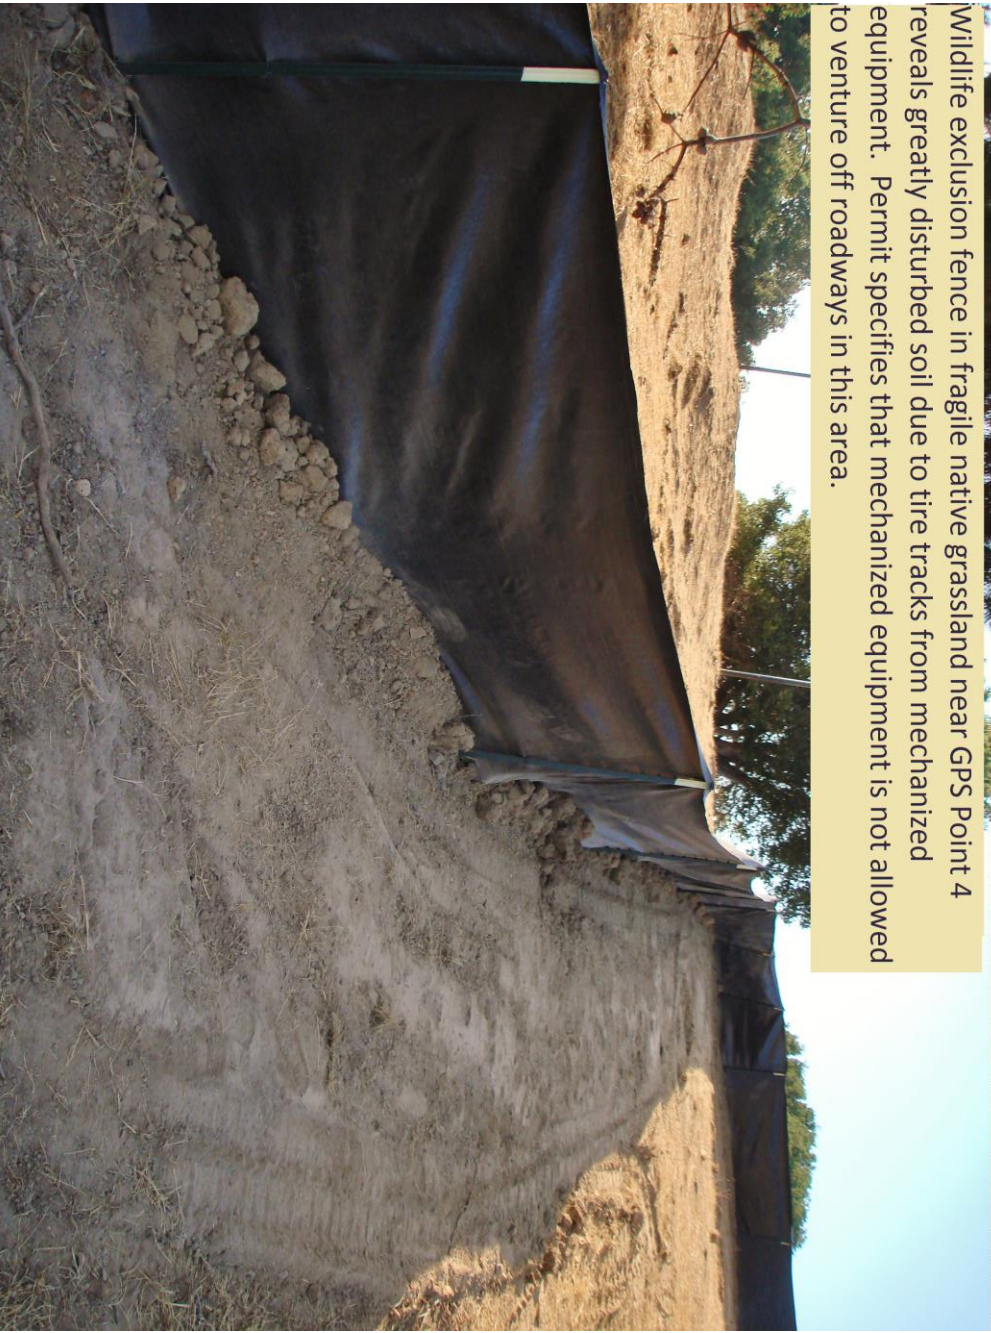
Wildlife exclusion fence in fragile native grassland near GPS Point 4 reveals greatly disturbed soil due to tire tracks from mechanized equipment. Permit specifies that mechanized equipment is not allowed to venture off roadways in this area.

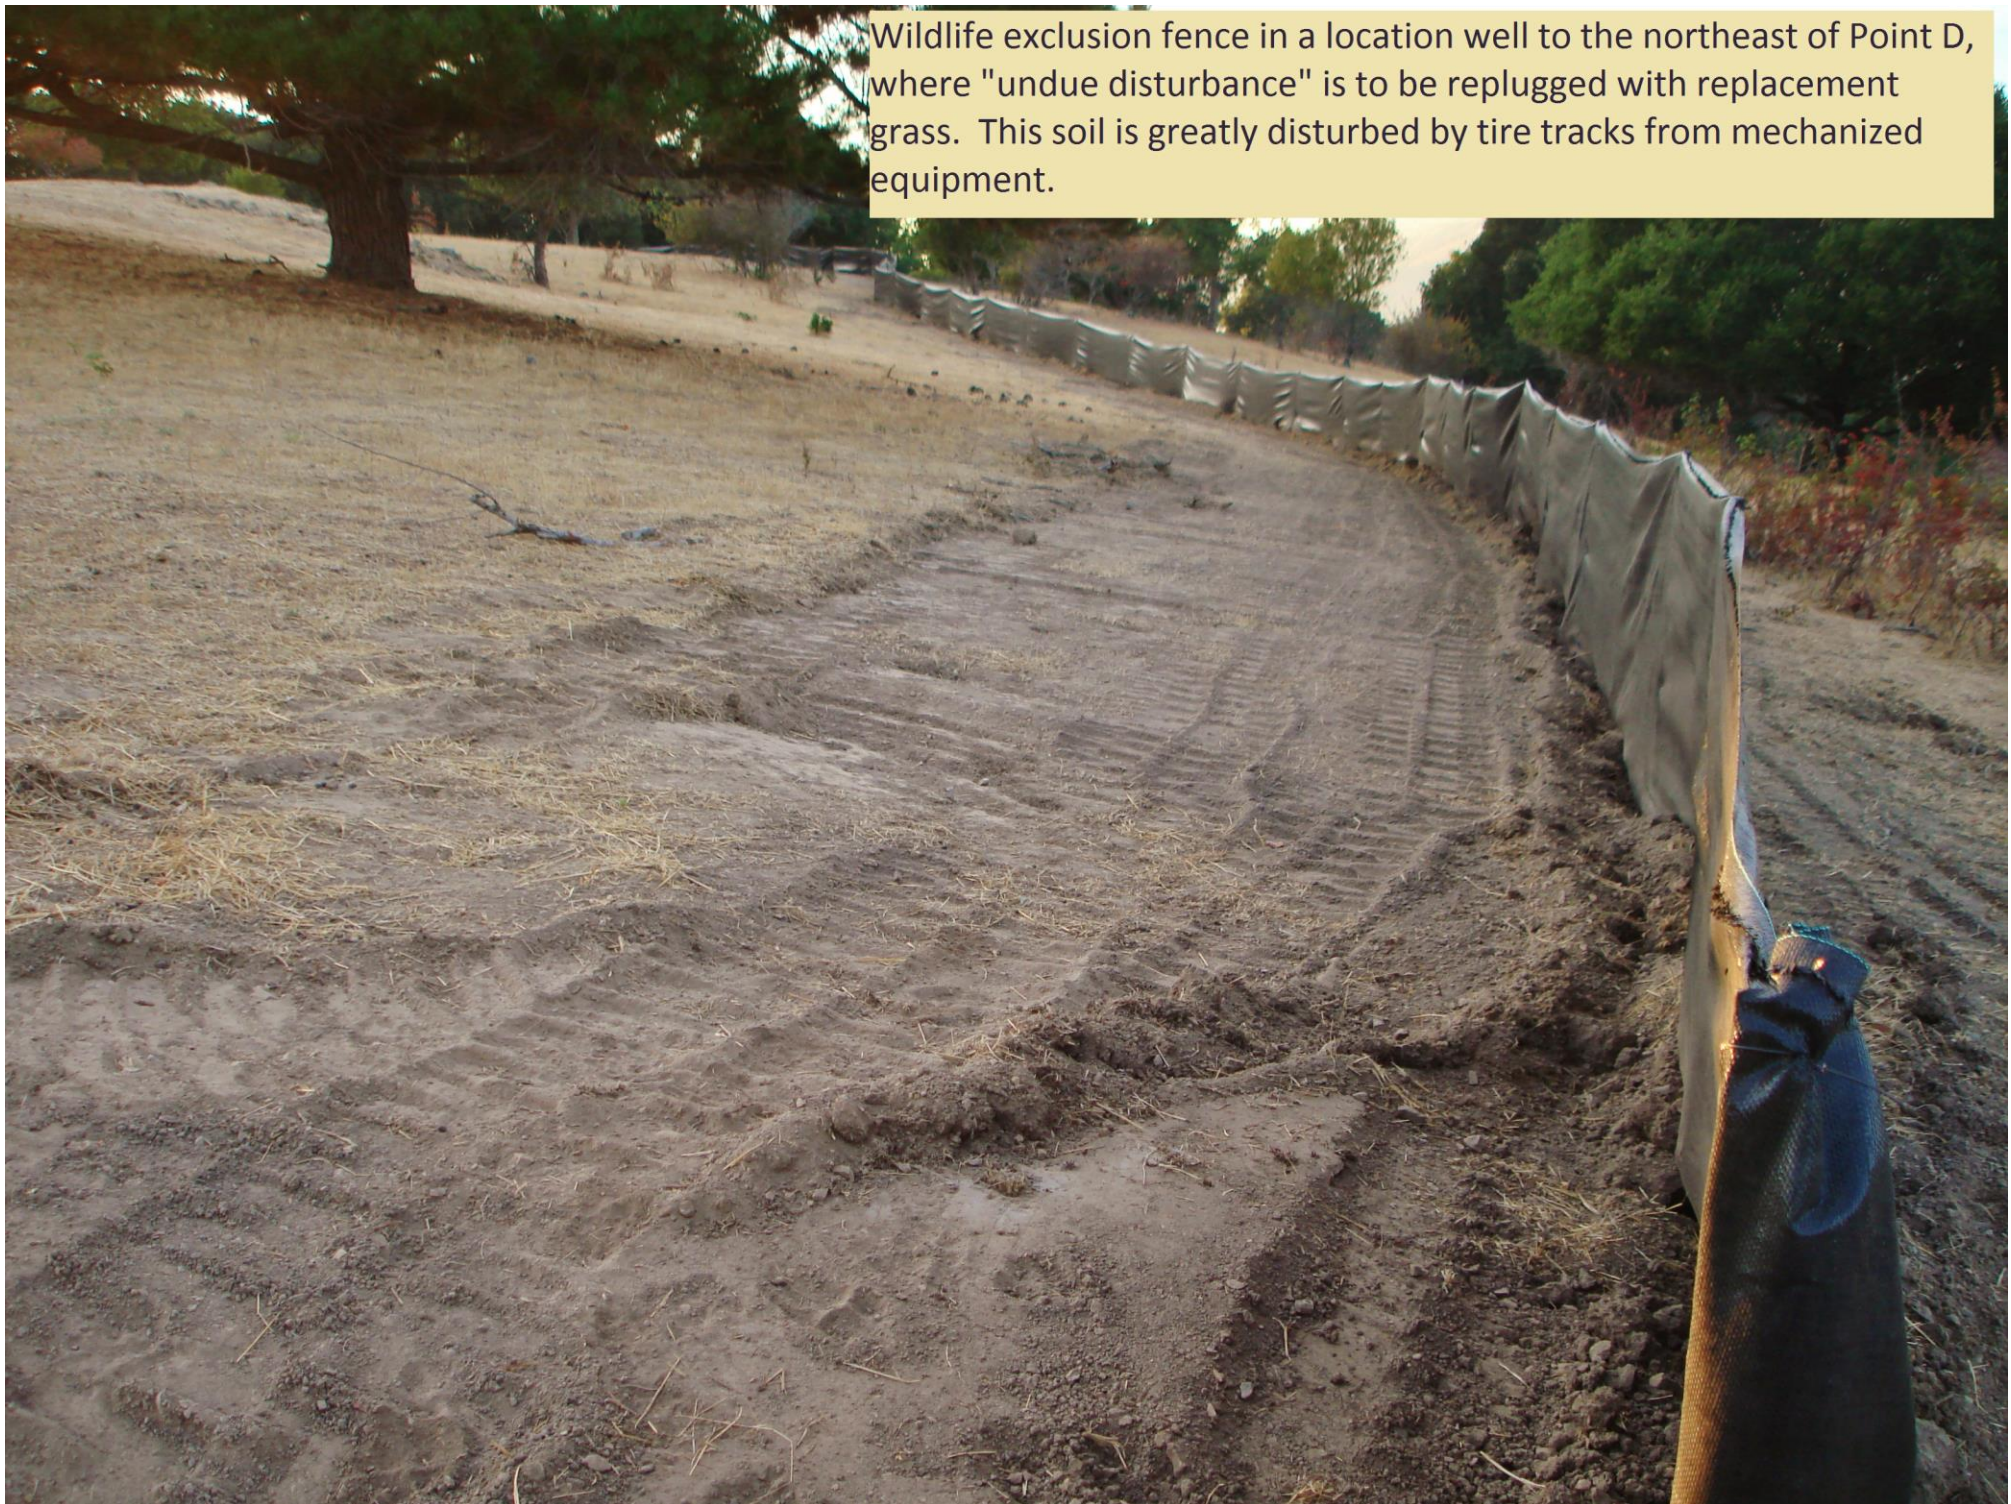
Wildlife exclusion fence in a location well to the northeast of Point D, where "undue disturbance" is to be replugged with replacement grass. This soil is greatly disturbed by tire tracks from mechanized equipment.
