February 22, 2016

Re: East Bay Zoological Society “California Trail” project – Violations of CDFW Incidental Take Permit

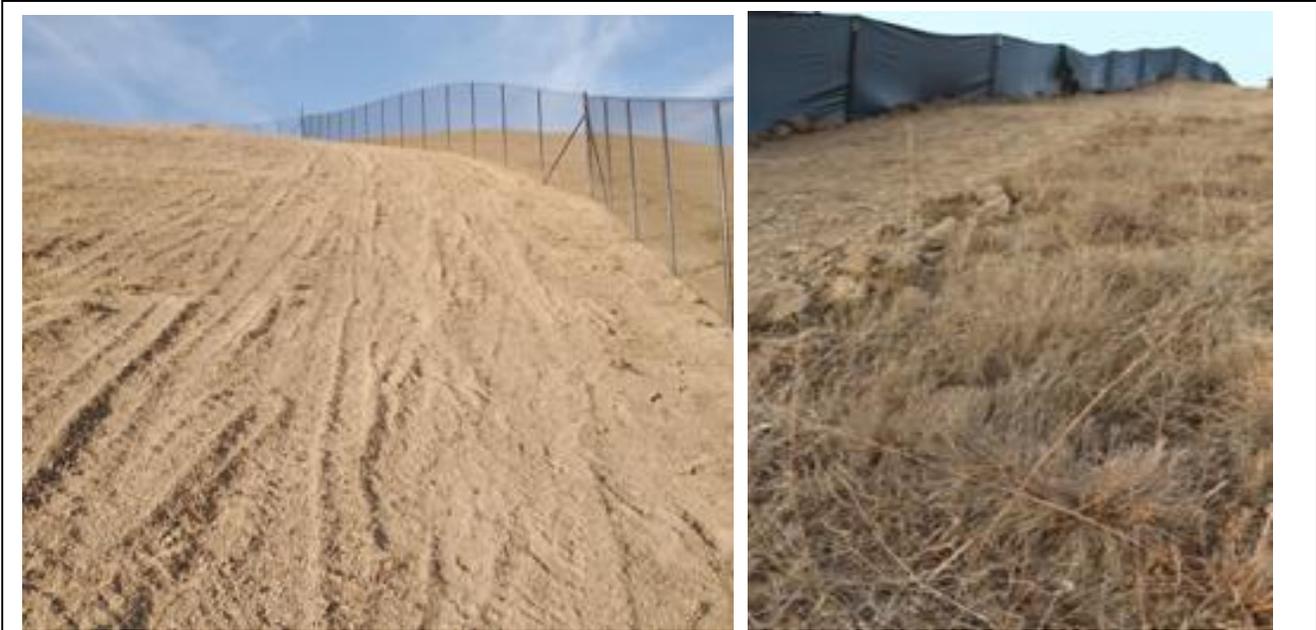
the City Planning Department acknowledges that parkland and habitat were damaged by EBZS construction. **(Figure 1.)** However, they contend that the environmental protections in the building permit – many mirroring the conditions for approval in your ITP – are not really regulatory *requirements*; instead, the City implies these protections are voluntary. An EBZS response that accompanied the City’s letter takes the same unobligated approach, seeks to divert attention from the damage, and waters down the need for EBZS to comply with the requirements of their environmental permits.

Figure 1. Example of unauthorized damage to former rare native grassland and Alameda striped racer habitat torn up during construction of perimeter fence (*left*) and wildlife exclusion fence (*right*).

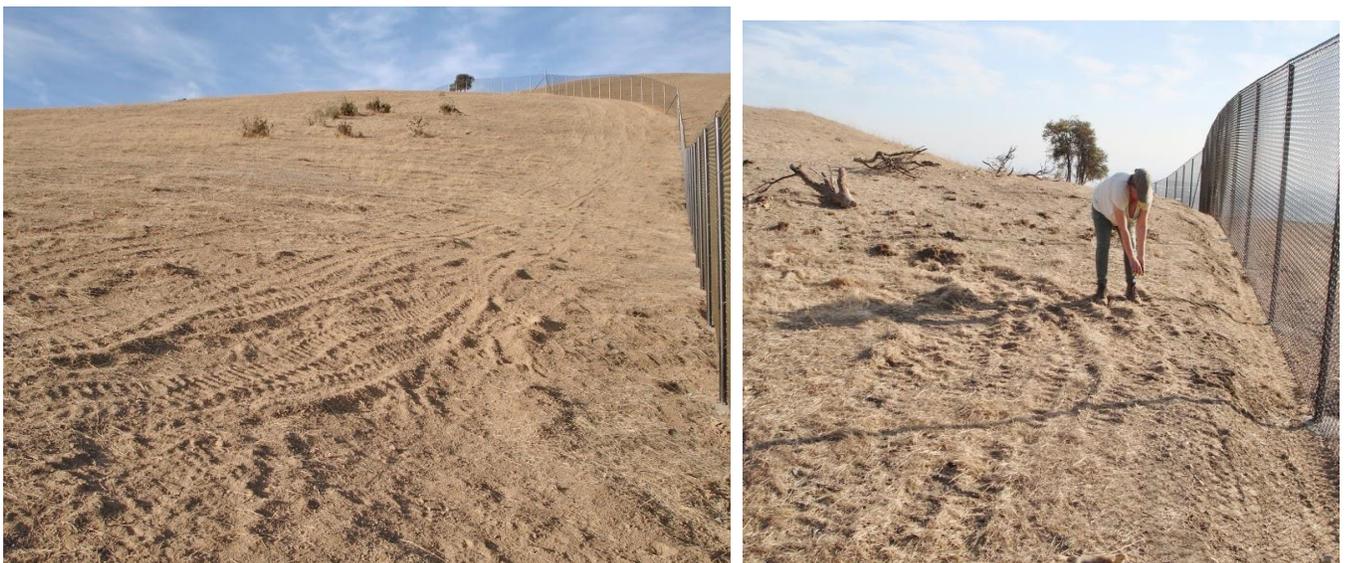
Figure 2. Knowland Park hillside immediately above Zoo with approximately 530 linear feet (estimated .41 acres) of unpermitted damage to protected grassland from construction equipment. Extensive soil-tear on both development and public sides of perimeter fence. Use of equipment here (Site Areas C–D) is prohibited by both CDFW and City permits. **Complaint sections 1a–e, h, 2a, c, d.**

As a result, damage occurred. (**Figure 2.**) A few flimsy signs marked “CE” (i.e., “conservation easement”) appeared on the site later, but well after widespread damage had been done to Alameda striped racer habitat and protected native grasslands.

This area is part of the conservation easement that CDFW accepted as mitigation for EBZS permanently eliminating existing areas of Covered Species’ (Alameda striped racer) habitat. The conservation easement is designated to be a protected area, but no protections were applied.

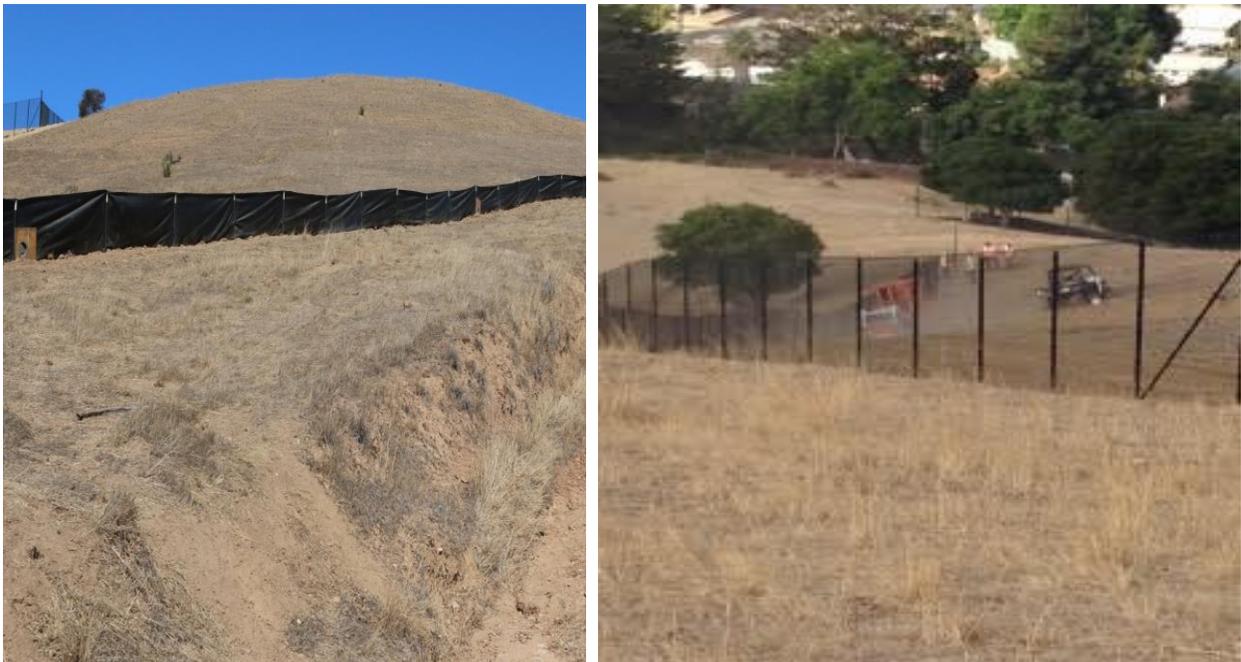
Figure 3. (left) Off-road equipment tracking and damage on protected native grassland and Alameda striped racer habitat above Zoo’s veterinary hospital (Site Areas C–D). Estimated **.10 acres** of unpermitted damage to public parkland. (right): EBZS construction vehicles being driven freely over protected rare native grasslands and ASR habitat in clear violation of EBZS permits. **Complaint sections 1a–e, g, h, 2a–d.**

Under the ITP and the City building permit, equipment is not permitted on Covered Species' (Alameda striped racer) habitat. Nevertheless, construction equipment has regularly trafficked across and damaged Covered Species' habitat and State-recognized rare native grasslands. Torn soils and equipment tracks were evident off-road in the project area, and also outside the project area in land that remains open public parkland. (Figure 3, Figure 4.)

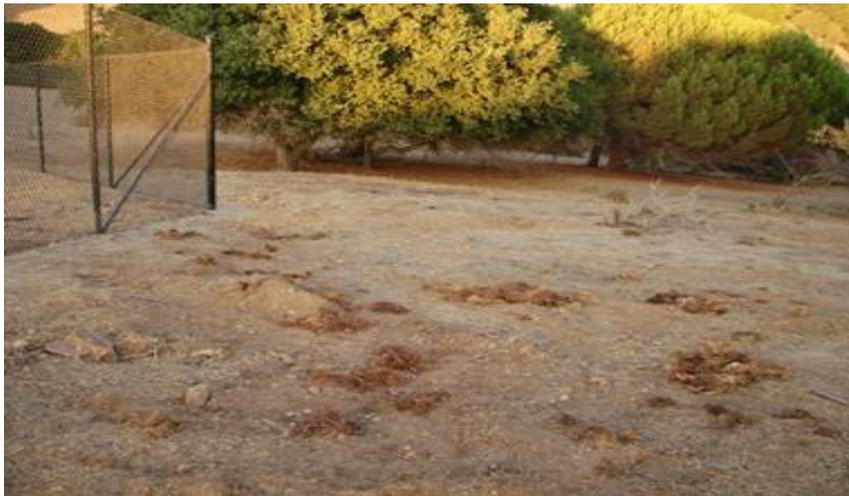
Figure 4. Southeast ridge (Site Areas E–E1) with approximately 40 linear feet x 25 feet = estimated **.02 acres** of unauthorized construction equipment damage to public parkland and protected native grassland outside development footprint. **Complaint sections 1a–d, f, h, 2a, c, d.**

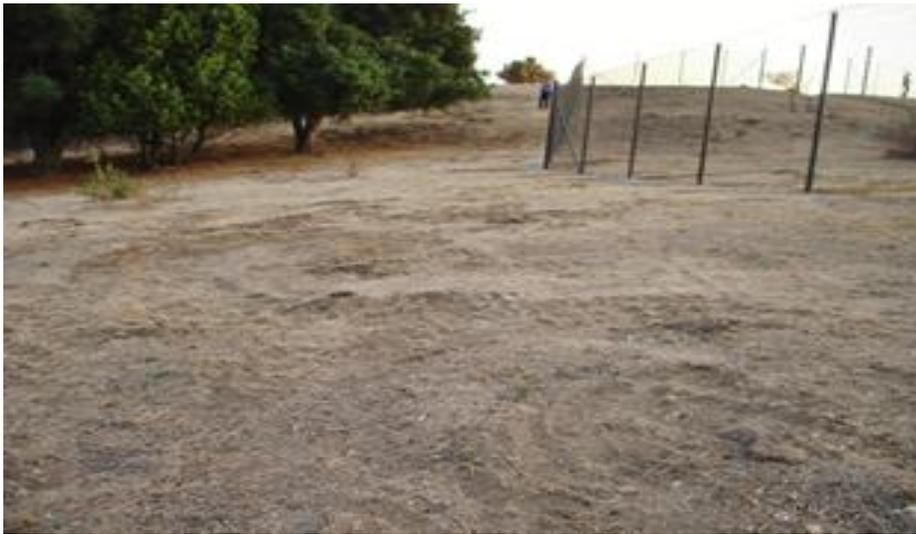
five feet of both sides of the perimeter fence line (site areas D–F in the perimeter fence building permit). But even with a lower standard of environmental protection, EBZS did not comply. In **Figure 5**, tire damage from tractor equipment is evident up to 30 feet on each side of the fence. This violation was not stopped by City building inspectors or by on-site EBZS biological monitors charged with ensuring permit compliance.

Figure 5. Unauthorized damage by equipment to public parkland and protected native grassland along perimeter fence, outside of project footprint. Top of southeast-facing fence (Site Areas E1–E2) – approximately 30 linear feet x 30 feet = estimated **.02 acres** of damage. **Complaint sections 1a–d, f, h; 2a, c, d.**

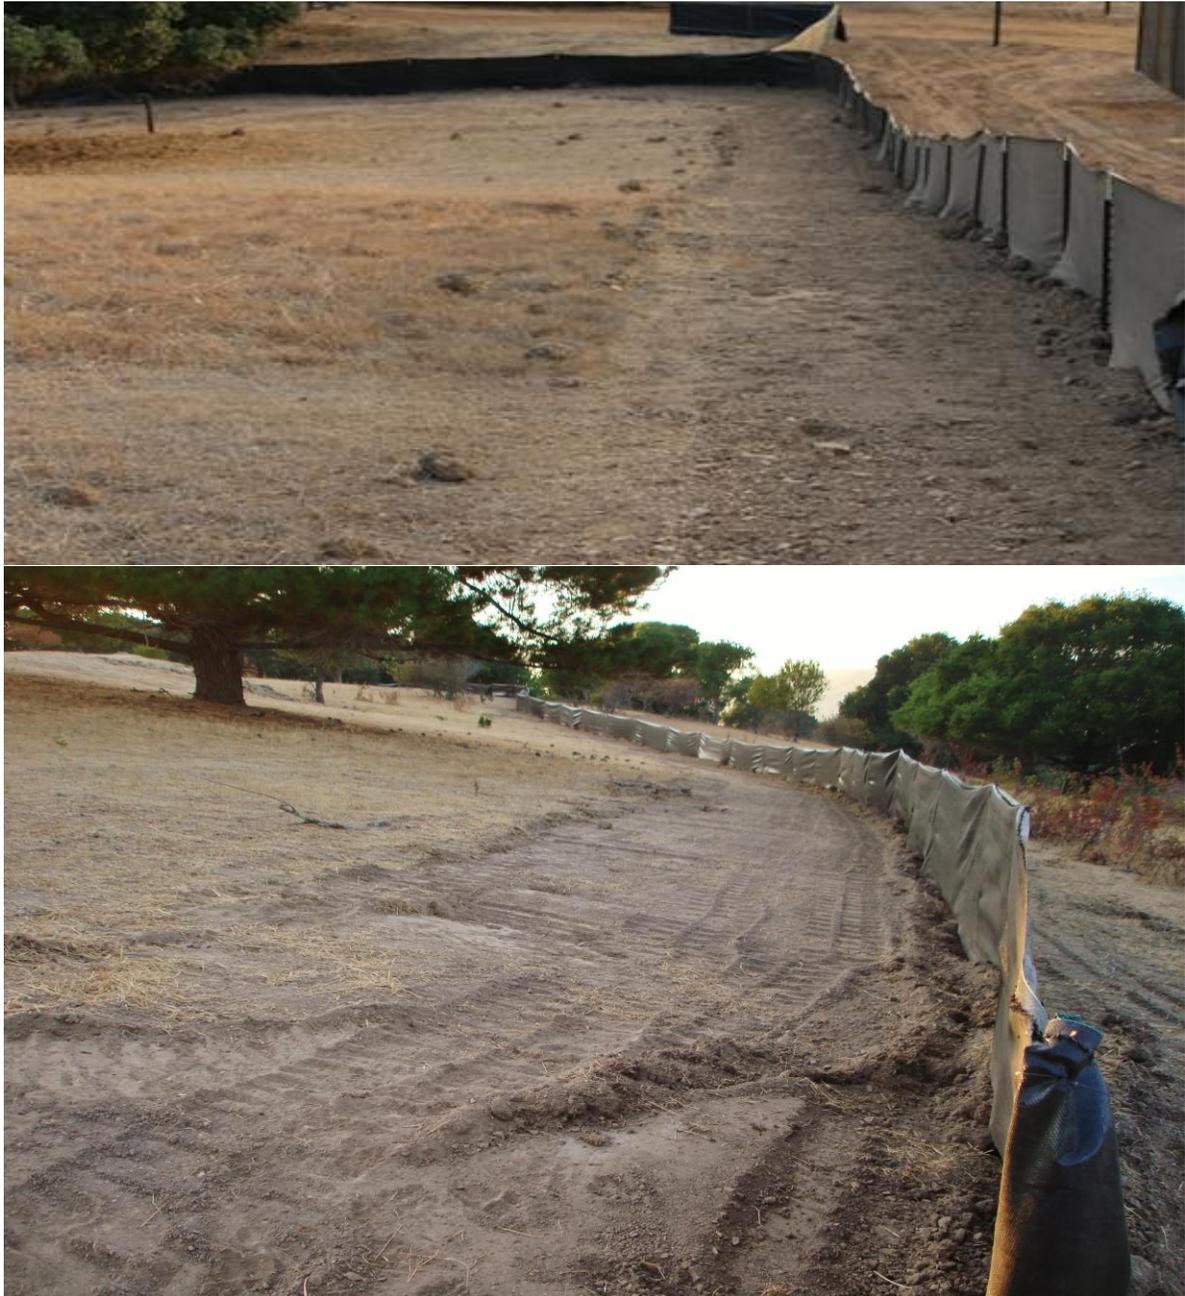
Figure 6. (top) EBZS trenching and scraping damage across original and intact native bunchgrass prairie for the wildlife exclusion fence. (Site Areas D–E). Approximately 1,700 linear feet x 7 feet = estimated **.27 acres** damage outside of project footprint. **Complaint sections 1a–c, g, h; 2b, c, d.** (bottom) Another example of the damaging method used to install the wildlife exclusion fence.

Mapping” of the SMND/A. (**Figure 6.**) Such permanent damage to this native grassland could have been avoided in two ways: 1) by taking the time needed to install the fence properly rather than sacrifice environmental protections for quick-and-dirty construction expedience, or 2) by using an available alternative fencing product specifically designed to eliminate the need for destructive trenching (see Attachment 2).

The area excessively damaged by the wildlife exclusion fence construction, especially the fencing outside the perimeter fence, needs to be promptly repaired. In particular, CDFW should require EBZS to submit a plan to relocate and reconstruct a wildlife exclusion fence that does not damage the area shown in Figure 6 and Attachment 1D, Site Areas D–E.

In addition, the seven-foot-wide band of grassland that was scraped along the full length of the wildlife exclusion fence is unpermitted damage. The method used to install this fencing was for construction expedience, with no regard for the protections in the permits for Alameda striped racer habitat or the protected native grasslands. Therefore, the sanctions discussed for “unpermitted impacts” (Section 2a above) need to be applied. This scraped area should be restored promptly to the richness and cover of background native grass and forb species indigenous to this site at a 3:1 ratio, consistent with mitigation measures.

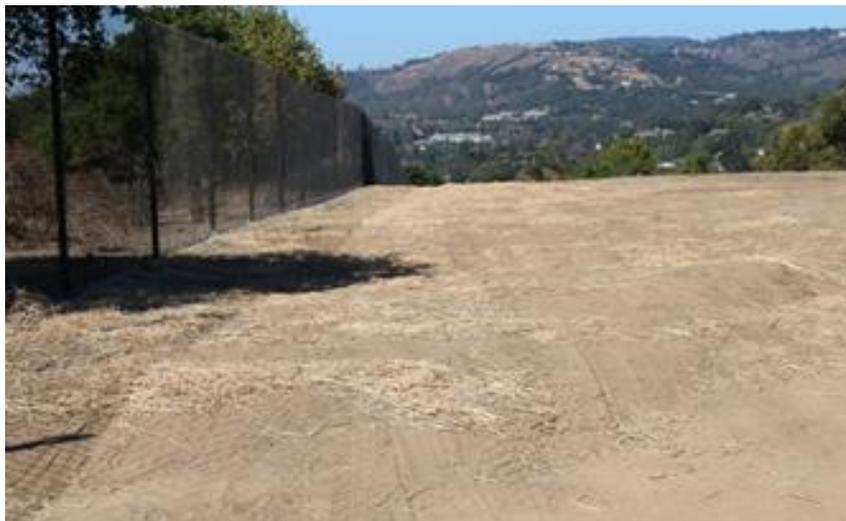
None of the agents entrusted to monitor construction and enforce permit requirements (not the EBZS on-site biological monitors, the supervising City building inspector as lead agency, nor EBZS management as the project permittee and “designated representative”) notified CDFW when habitat damage started above the veterinary hospital or as it continued. It was Oakland citizens and environmental organization volunteers concerned for the park’s natural resources who notified the City Planning and Building Department and the regulatory agencies about EBZS’s failure to comply with conditions of approval. (Figure 7.)

Figure 7. Unauthorized damage by prohibited equipment to protected native grassland along east-facing perimeter fence in public parkland outside the development footprint (Site Areas E2–F). Approximately 450 linear feet x 25’ = estimated .26 acres. **Complaint sections 1a–d, f, h; 2a, c, d.**

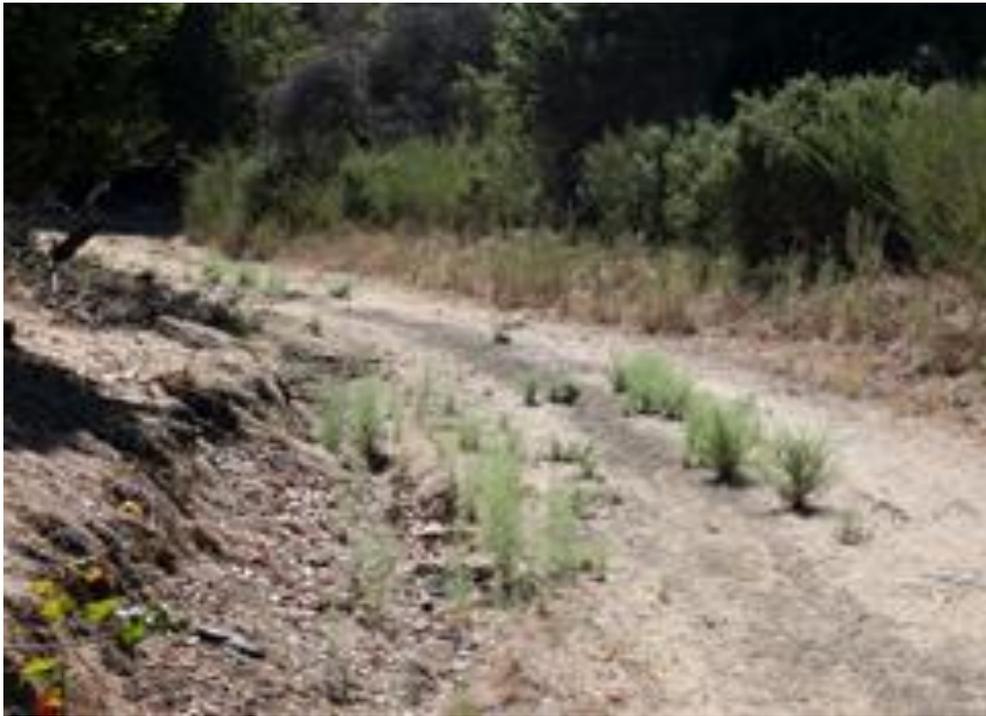
Figure 8. Left unattended, invading stinkwort (*Dittrichia graveolens*) in Knowland Park is moving up the north access fire road from Golf Links Road, with untreated broom (*Genista monspessulana*) behind it. (October 2015) **Complaint sections 2c, 3.**

Since July 2015, when project construction began, not only have small areas of invasive broom gone unattended, but a new invasive weed, stinkwort (*Dittrichia graveolens*), has been making inroads into the park via disturbed areas. This new, harmful weed remained unattended in 2015, despite the permit requirements to control invasive weeds when ‘Covered Activities’ commenced.

Stinkwort is noxious and has the potential to take over the disturbed soil surfaces, in addition to the fire roads scraped by the City over the years. Stinkwort has been implicated in livestock deaths, and therefore may pose harm to grazing wildlife. **(Figure 8.)**

Invasive non-native weeds that are introduced or spread due to the disturbed soil conditions should be completely eradicated, starting now with the 2016 rainy season.

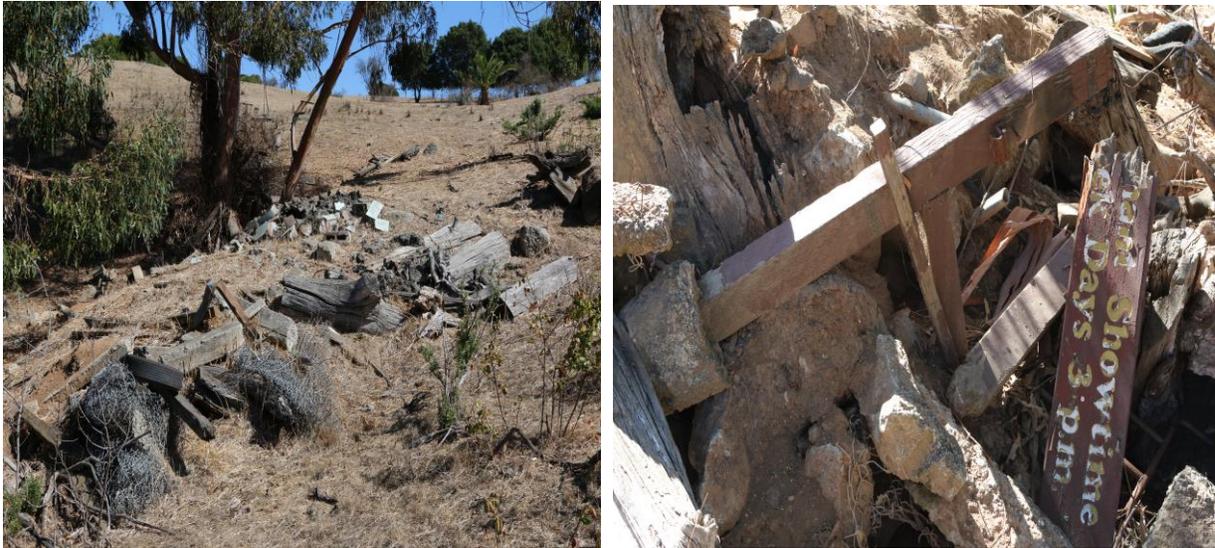
complaints, Dr. Joel Parrott and Nik Dehejia of EBZS sent a memo on June 3, 2011 to the Oakland City Council stating that the Zoo debris filling the park swale would be removed within 60 days. In 2016, it remains jutting out from the swale and draining into the creek (**Figure 9**). As this example illustrates, EBZS compliance with environmental permits will require active monitoring and enforcement, beyond EBZS written assurances.

Figure 9. Zoo exhibit debris dumped in Knowland Park was to be removed in 2011, but remains in a swale draining to Arroyo Viejo Creek to this day.

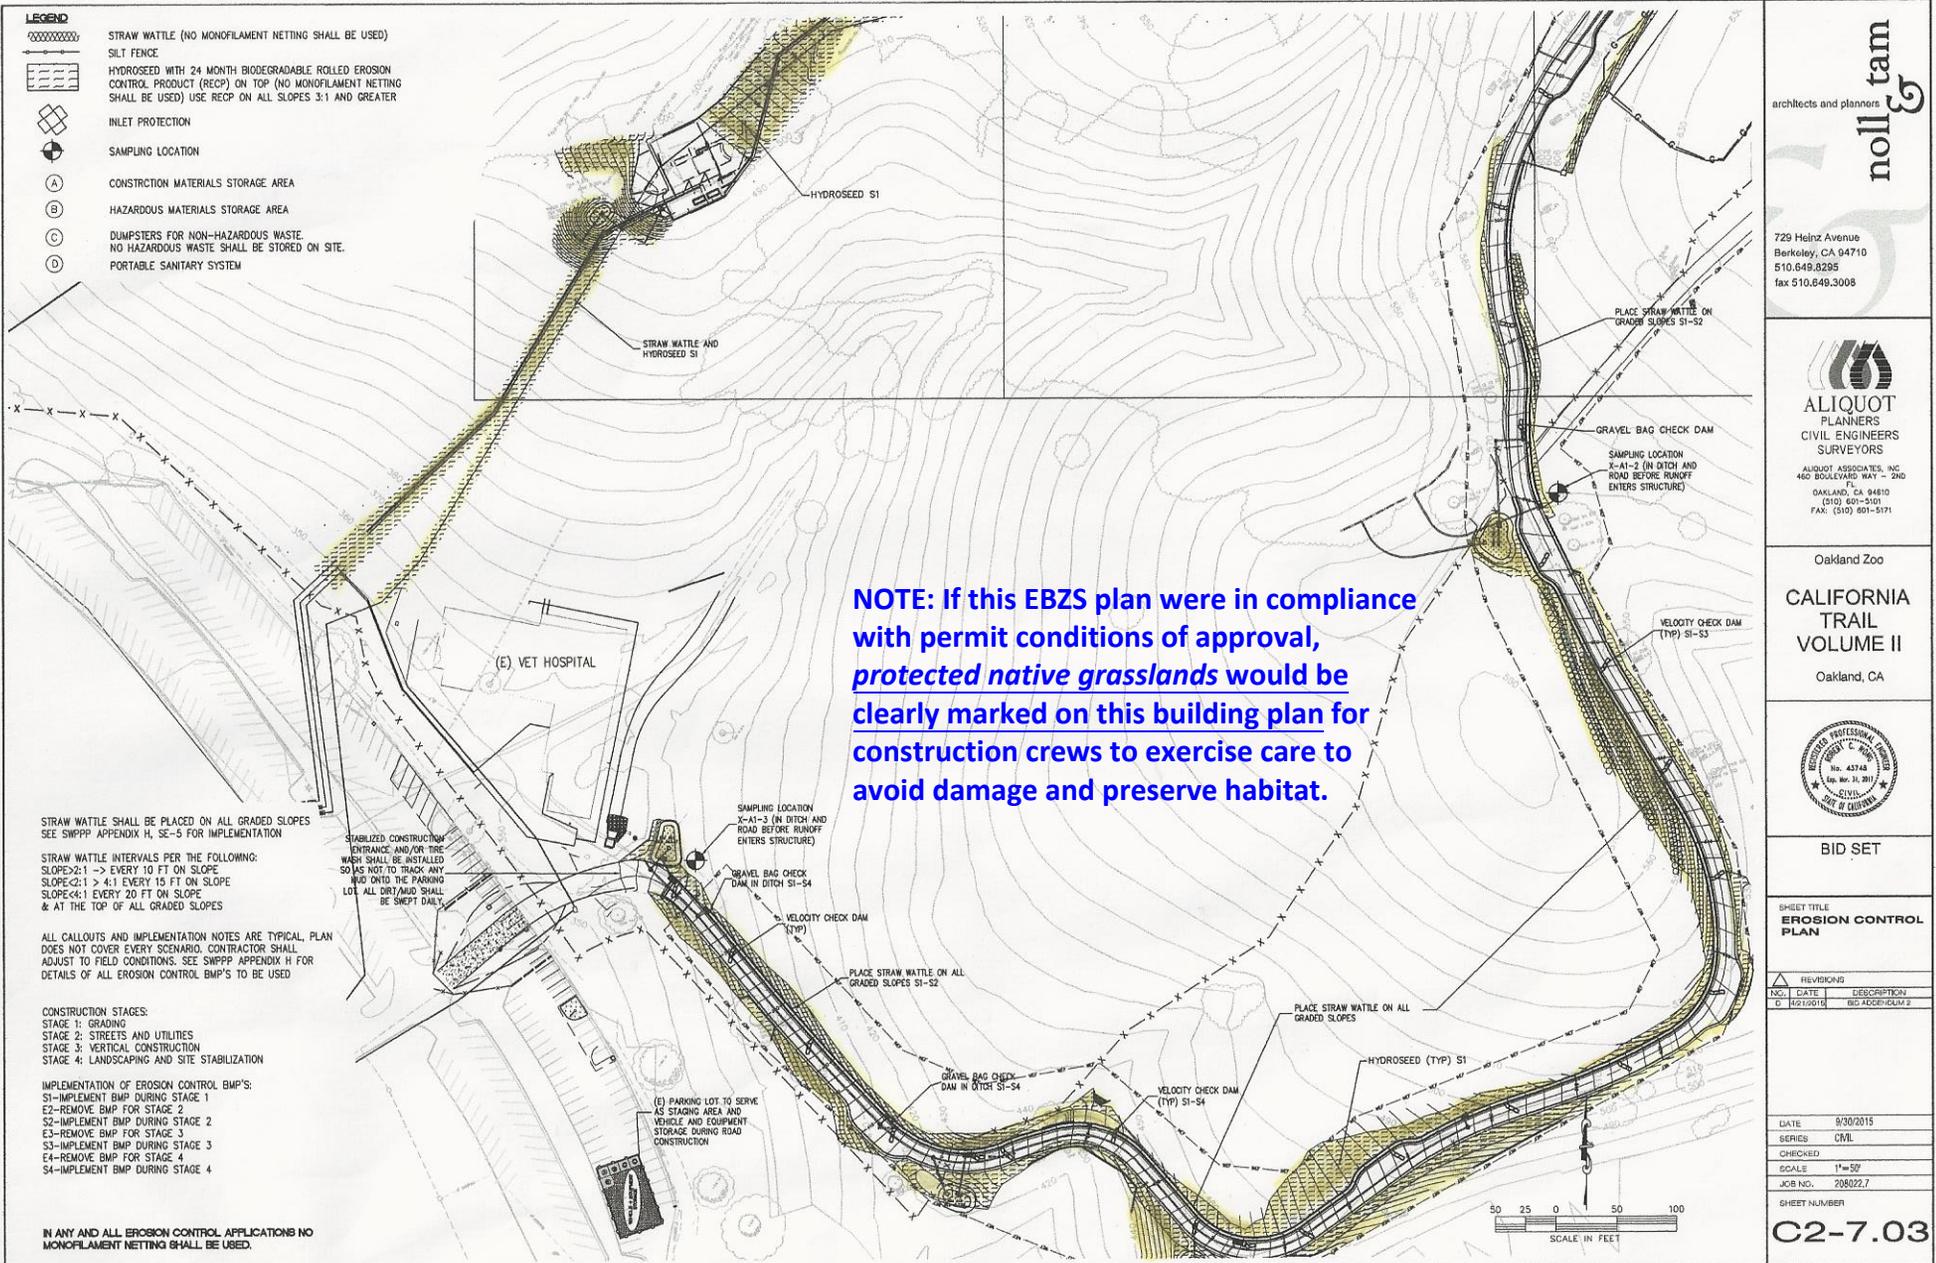
Attachment 1B - Example of EBZS CA Trail building plan with no designation of protected native grasslands
 In direct violation of their regulatory permits, EBZS ignored requirement to map locations of "protected native grasslands" on all building plans.

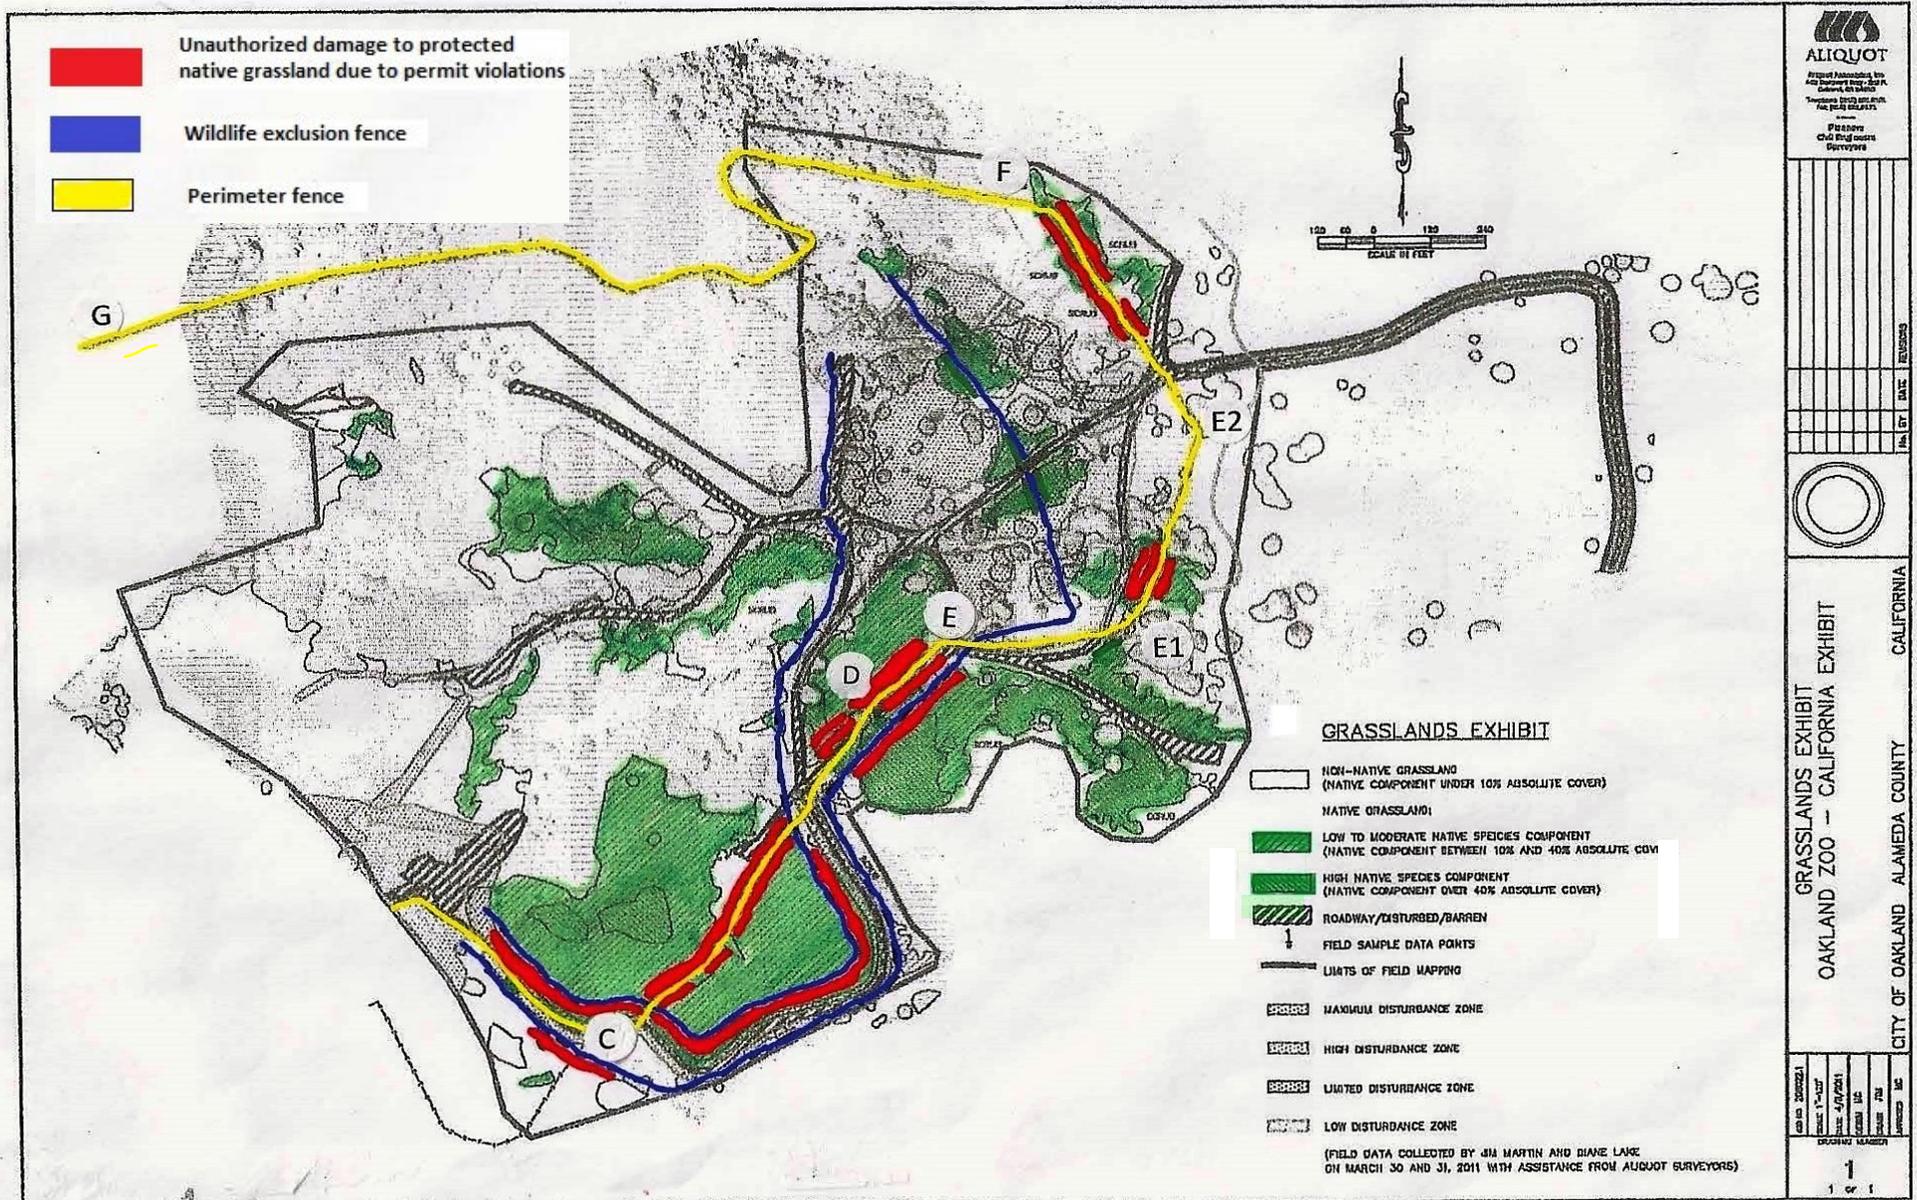
Attachment 1D: Overview of protected rare native grasslands/Alameda striped racer habitat damaged by EBZS construction in violation of environmental permits

At least 1 acre of unpermitted damage is noted from project boundaries; acreage is clearly an underestimate and requires independent inventory. Damage further inside the project site is unknown. Lettered areas are taken from City building permits #GR1500068 – #PZ1500051 for perimeter fence.

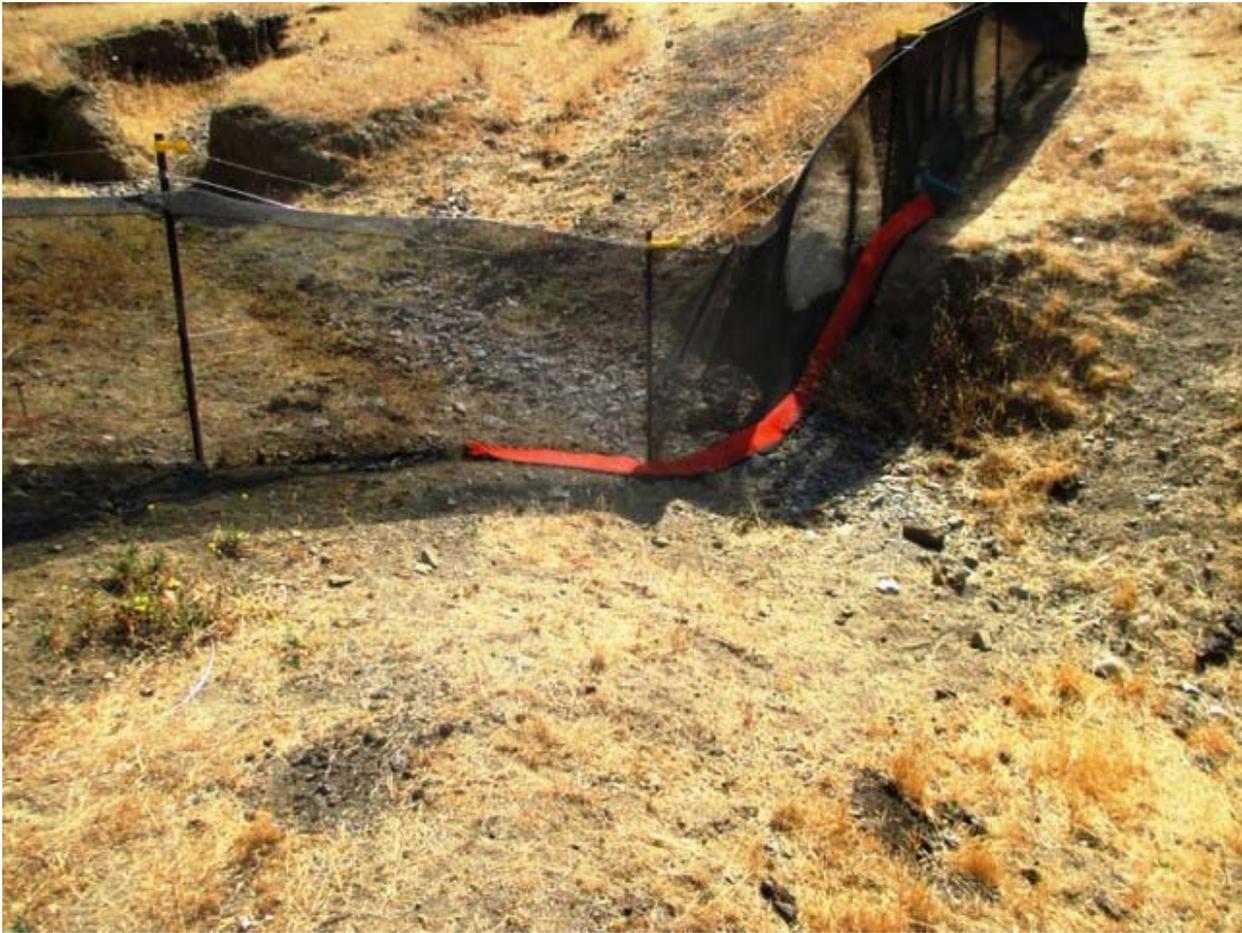
“No-trench” wildlife exclusion fence – available and non-destructive alternative

From manufacturer’s product description of a commercially-available wildlife exclusion fence:

“No-Trench Ground-Seal – An excellent option for areas that cannot be trenched such as: across creek areas with ephemeral flows, areas with no storm water permit, slopes, rough terrain, remote areas difficult to reach with trenching equipment, **areas where there is a preference not to disturb the soil.”**

“Partial list of approved configurations: **Alameda striped racer (*Masticophis lateralis euryxanthus*)**, Arroyo toad (*Bufo microscaphus californicus*), Blunt-nosed leopard lizard (*Gambelia sila*), California red-legged frog (*Rana draytonii*), California tiger salamander (*Ambystoma californiense*), Coachella Valley fringe-toed lizard (*Uma inornata*), Desert tortoise (*Gopherus agassizii*), Foothill yellow-legged frog (*Rana boylei*), Giant garter snake (*Thamnophis gigas*), Giant kangaroo rat (*Dipodomys ingens*), Mojave ground squirrel (*Xerospermophilus mohavensis*), Northern cricket frog (*Acris crepitans*), Pacific tree frog (*Pseudacris regilla*), Riparian brush rabbit (*Sylvilagus bachmani riparius*), Salt marsh harvest mouse (*Reithrodontomys raviventris*), San Bernardino kangaroo rat (*Dipodomys merriami parvus*), San Francisco garter snake (*Thamnophis sirtalis tetrataenia*)...”
